# Repair of Sakura Gomon's Ishigaki [Stone Wall]

## Damage from Takamatsu Air Raids

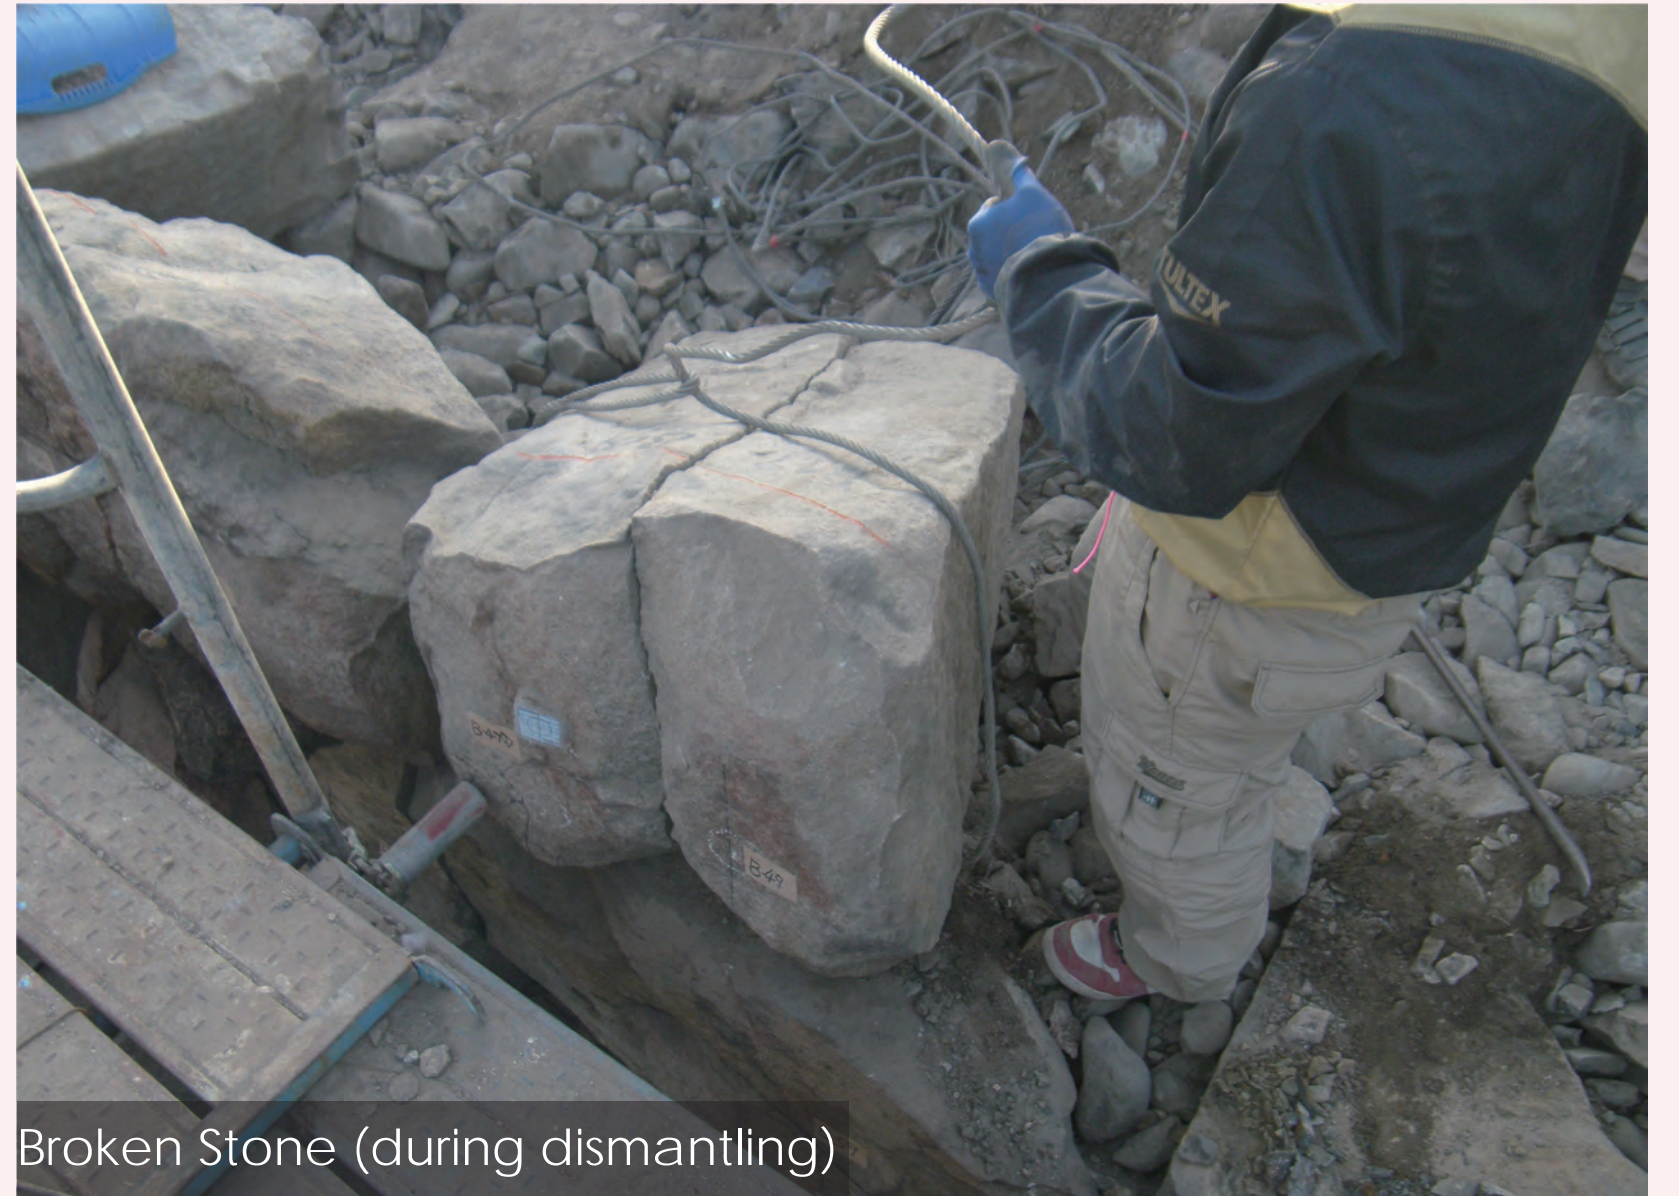
When the gate was lost to fire in the air raids, the *Ishigaki* [stone wall] was also severely damaged. The surface was discolored red, and cracks and broken stones were noticeable. The restoration of the Sakura Gomon began with repairing the stone wall that formed its foundation.

Broken Stone (during dismantling)

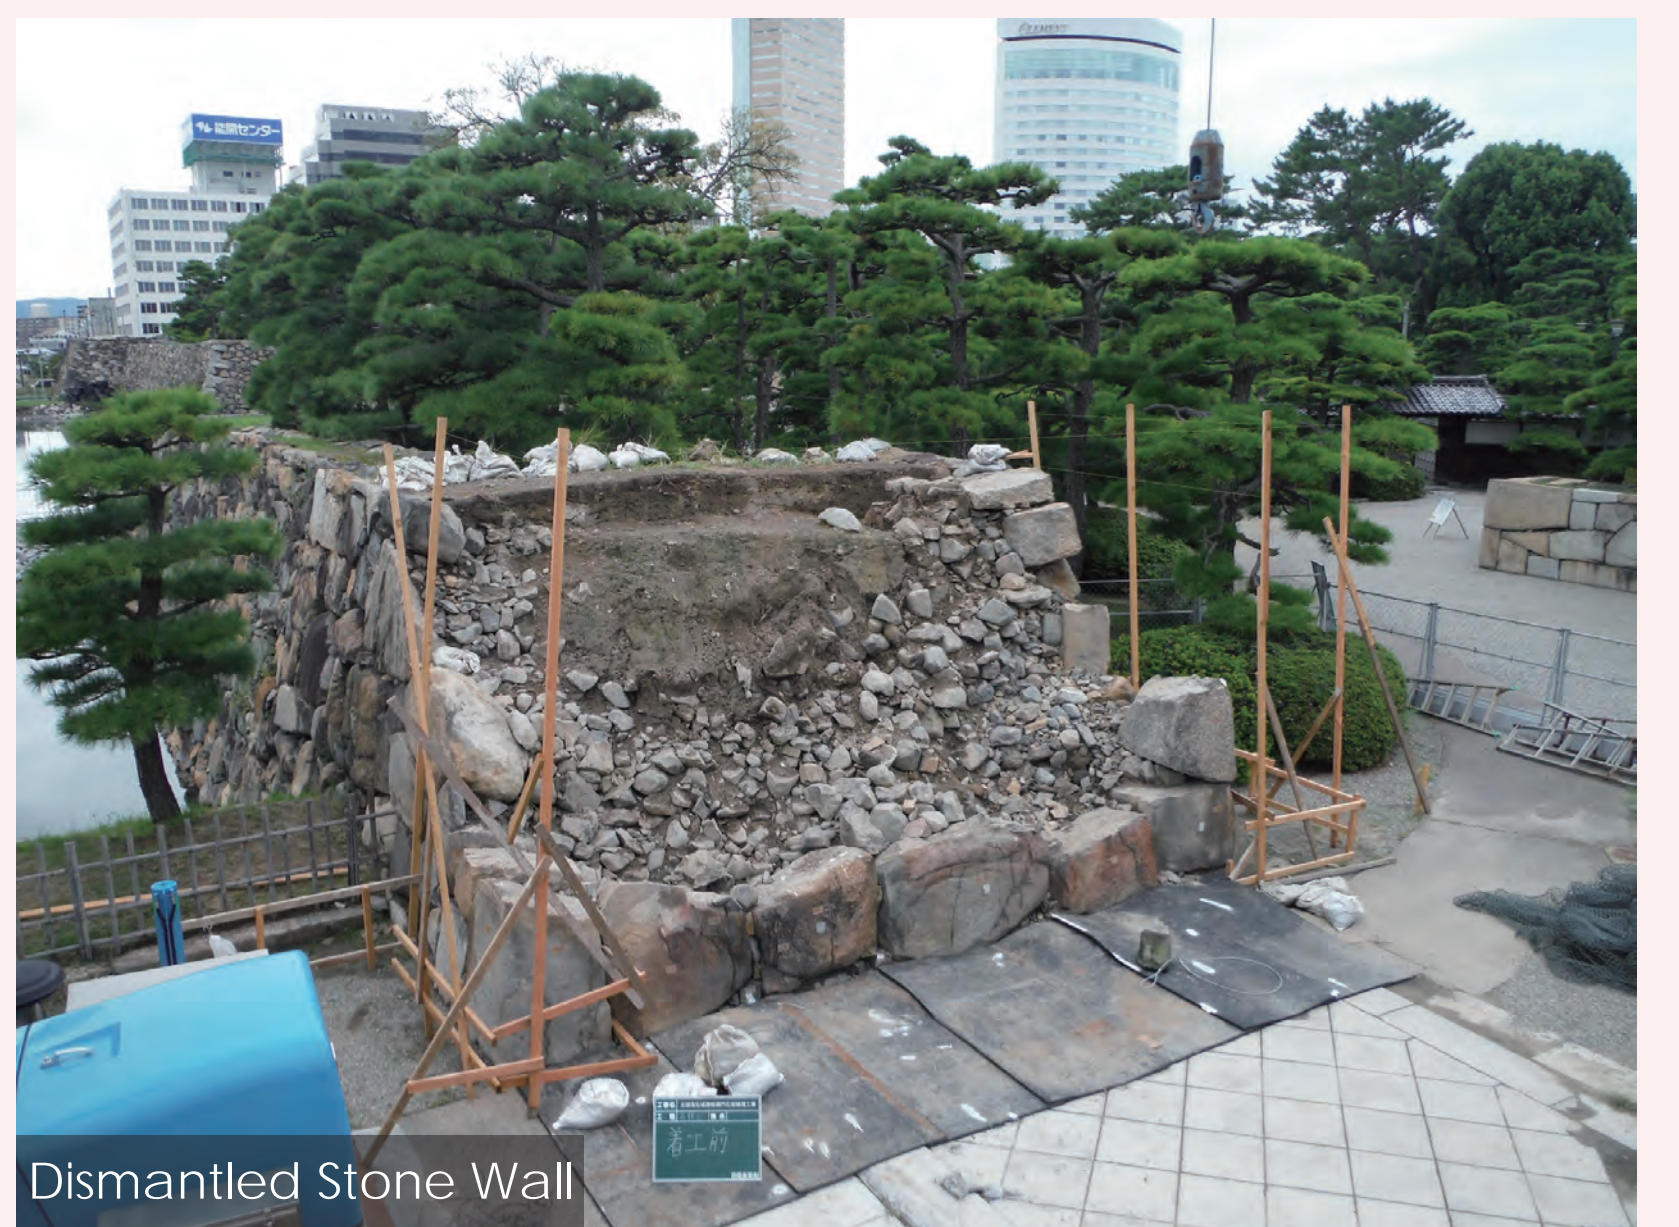
Dismantled Stone Wall

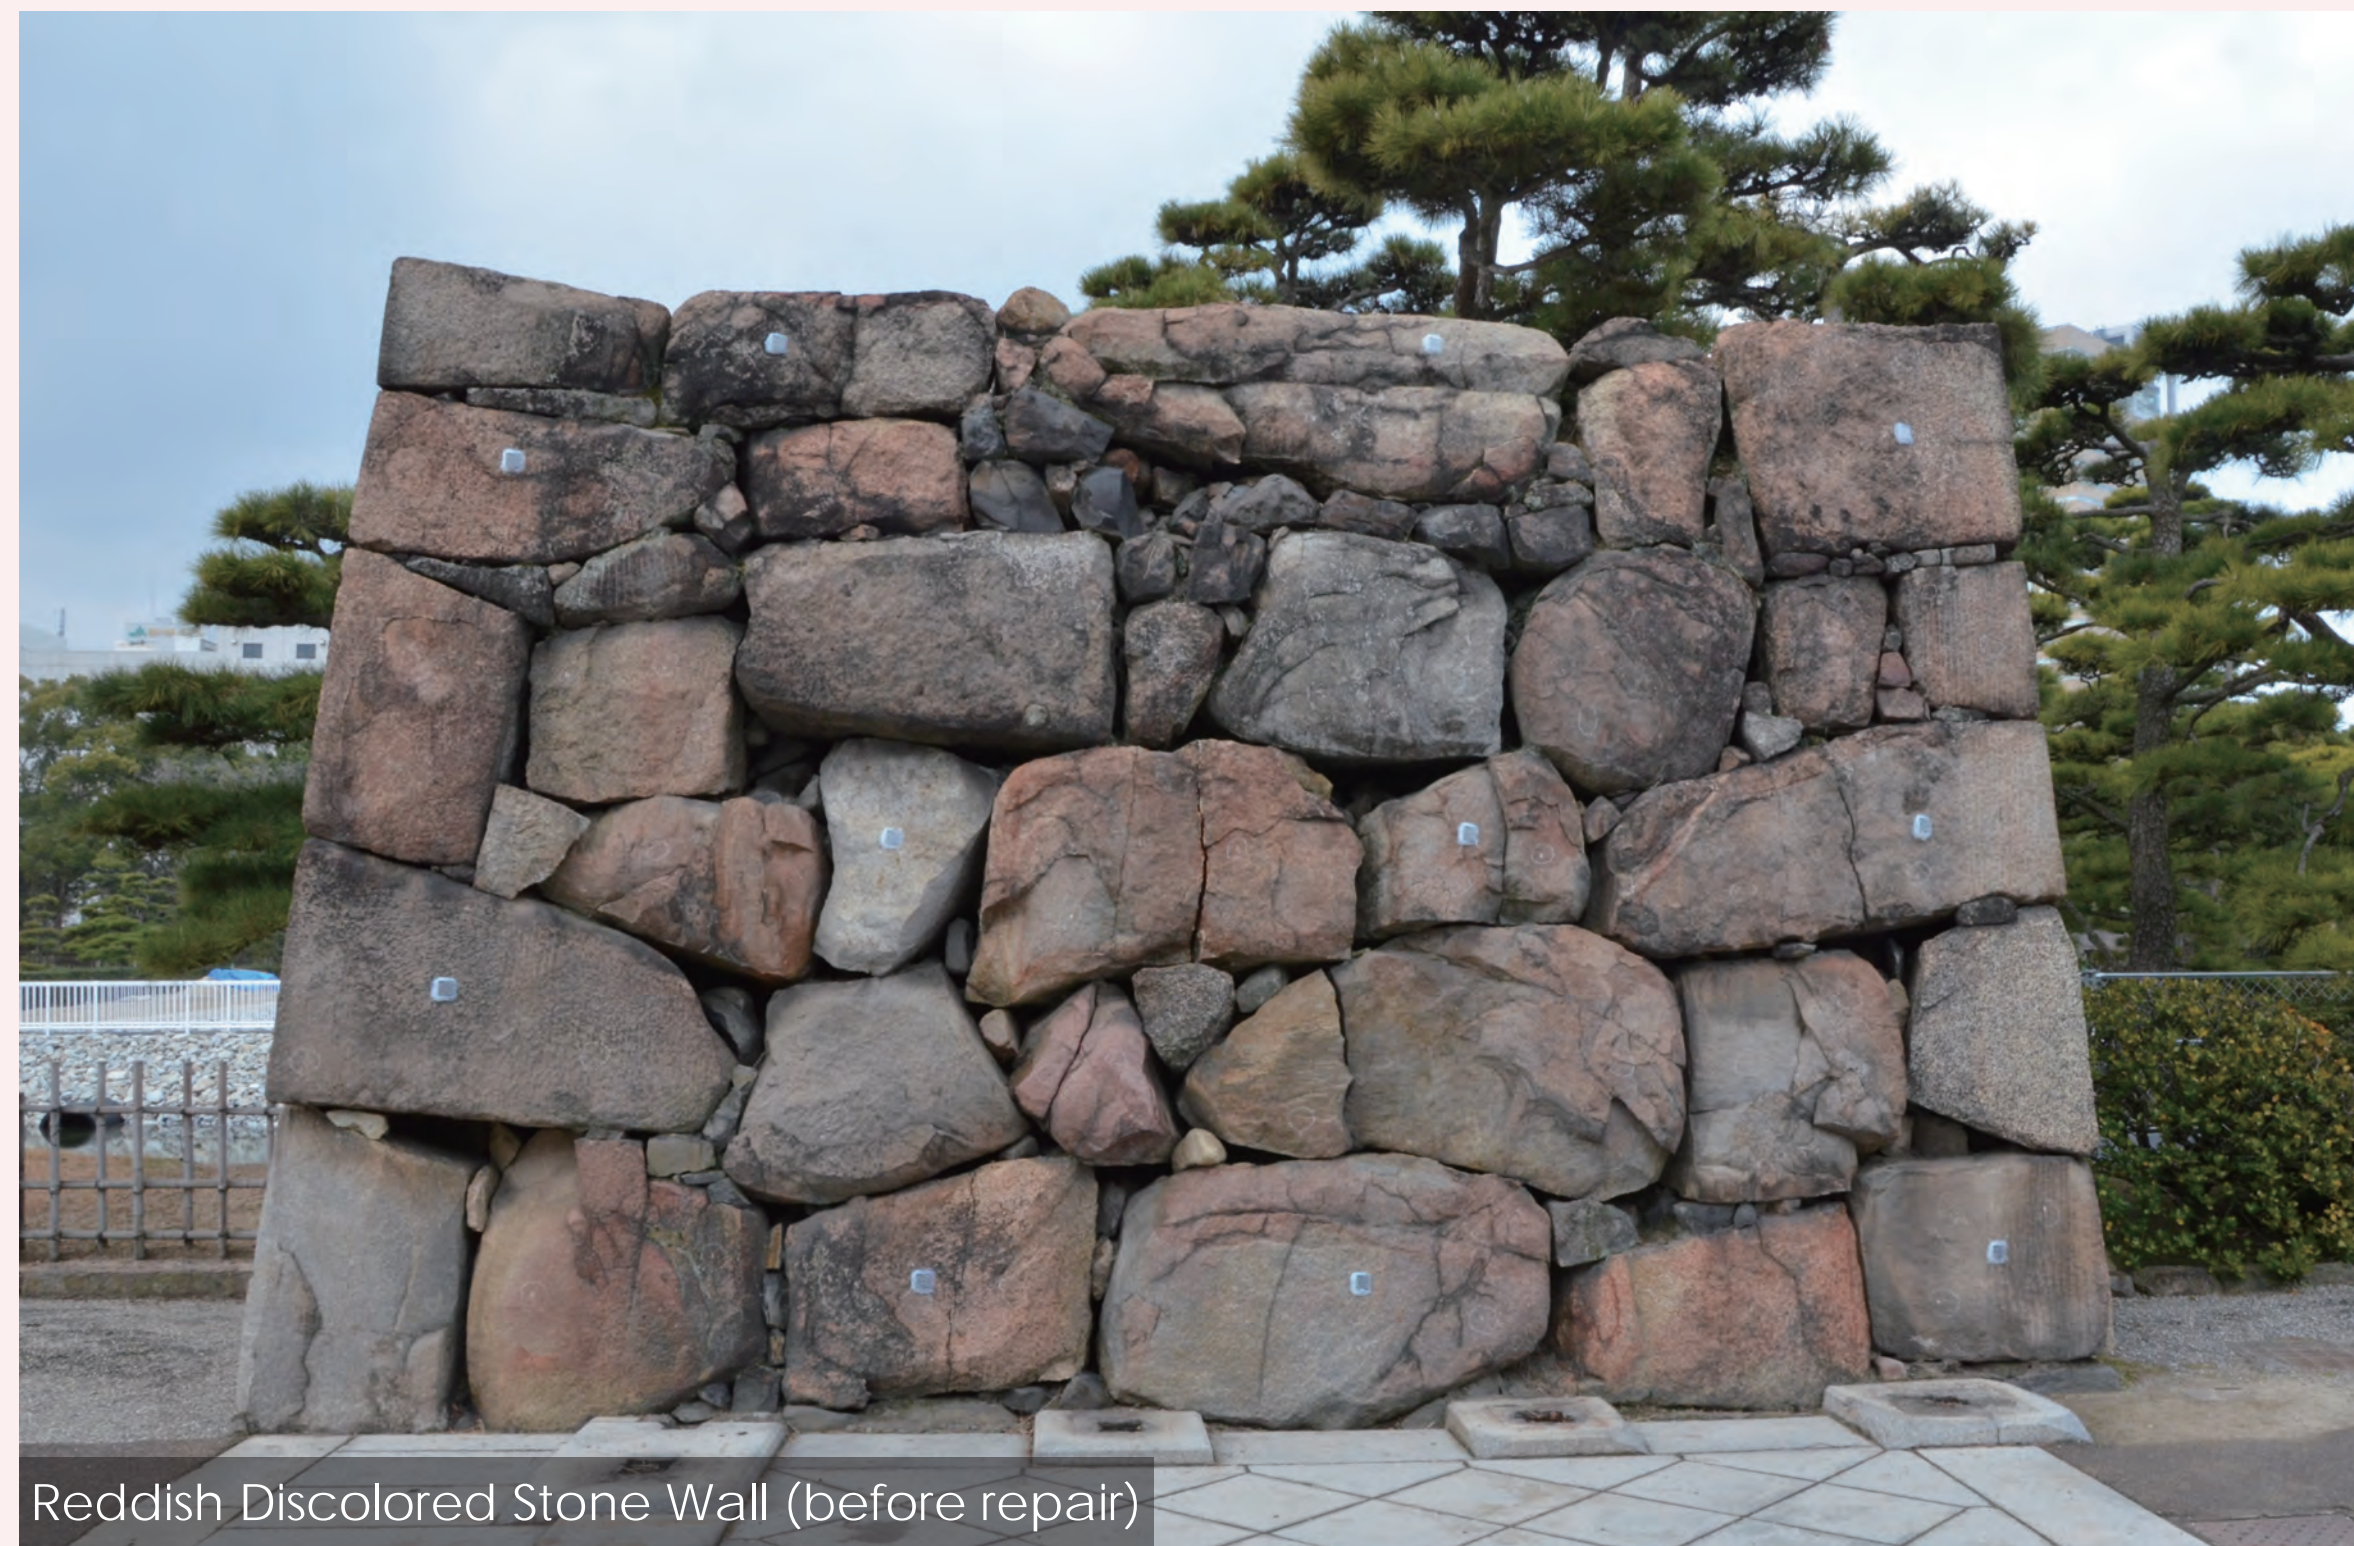
Reddish Discolored Stone Wall (before repair)
