Repair of Sakura Gomon' s Ishigaki [Stone Wall]

Damage from Takamatsu Air Raids

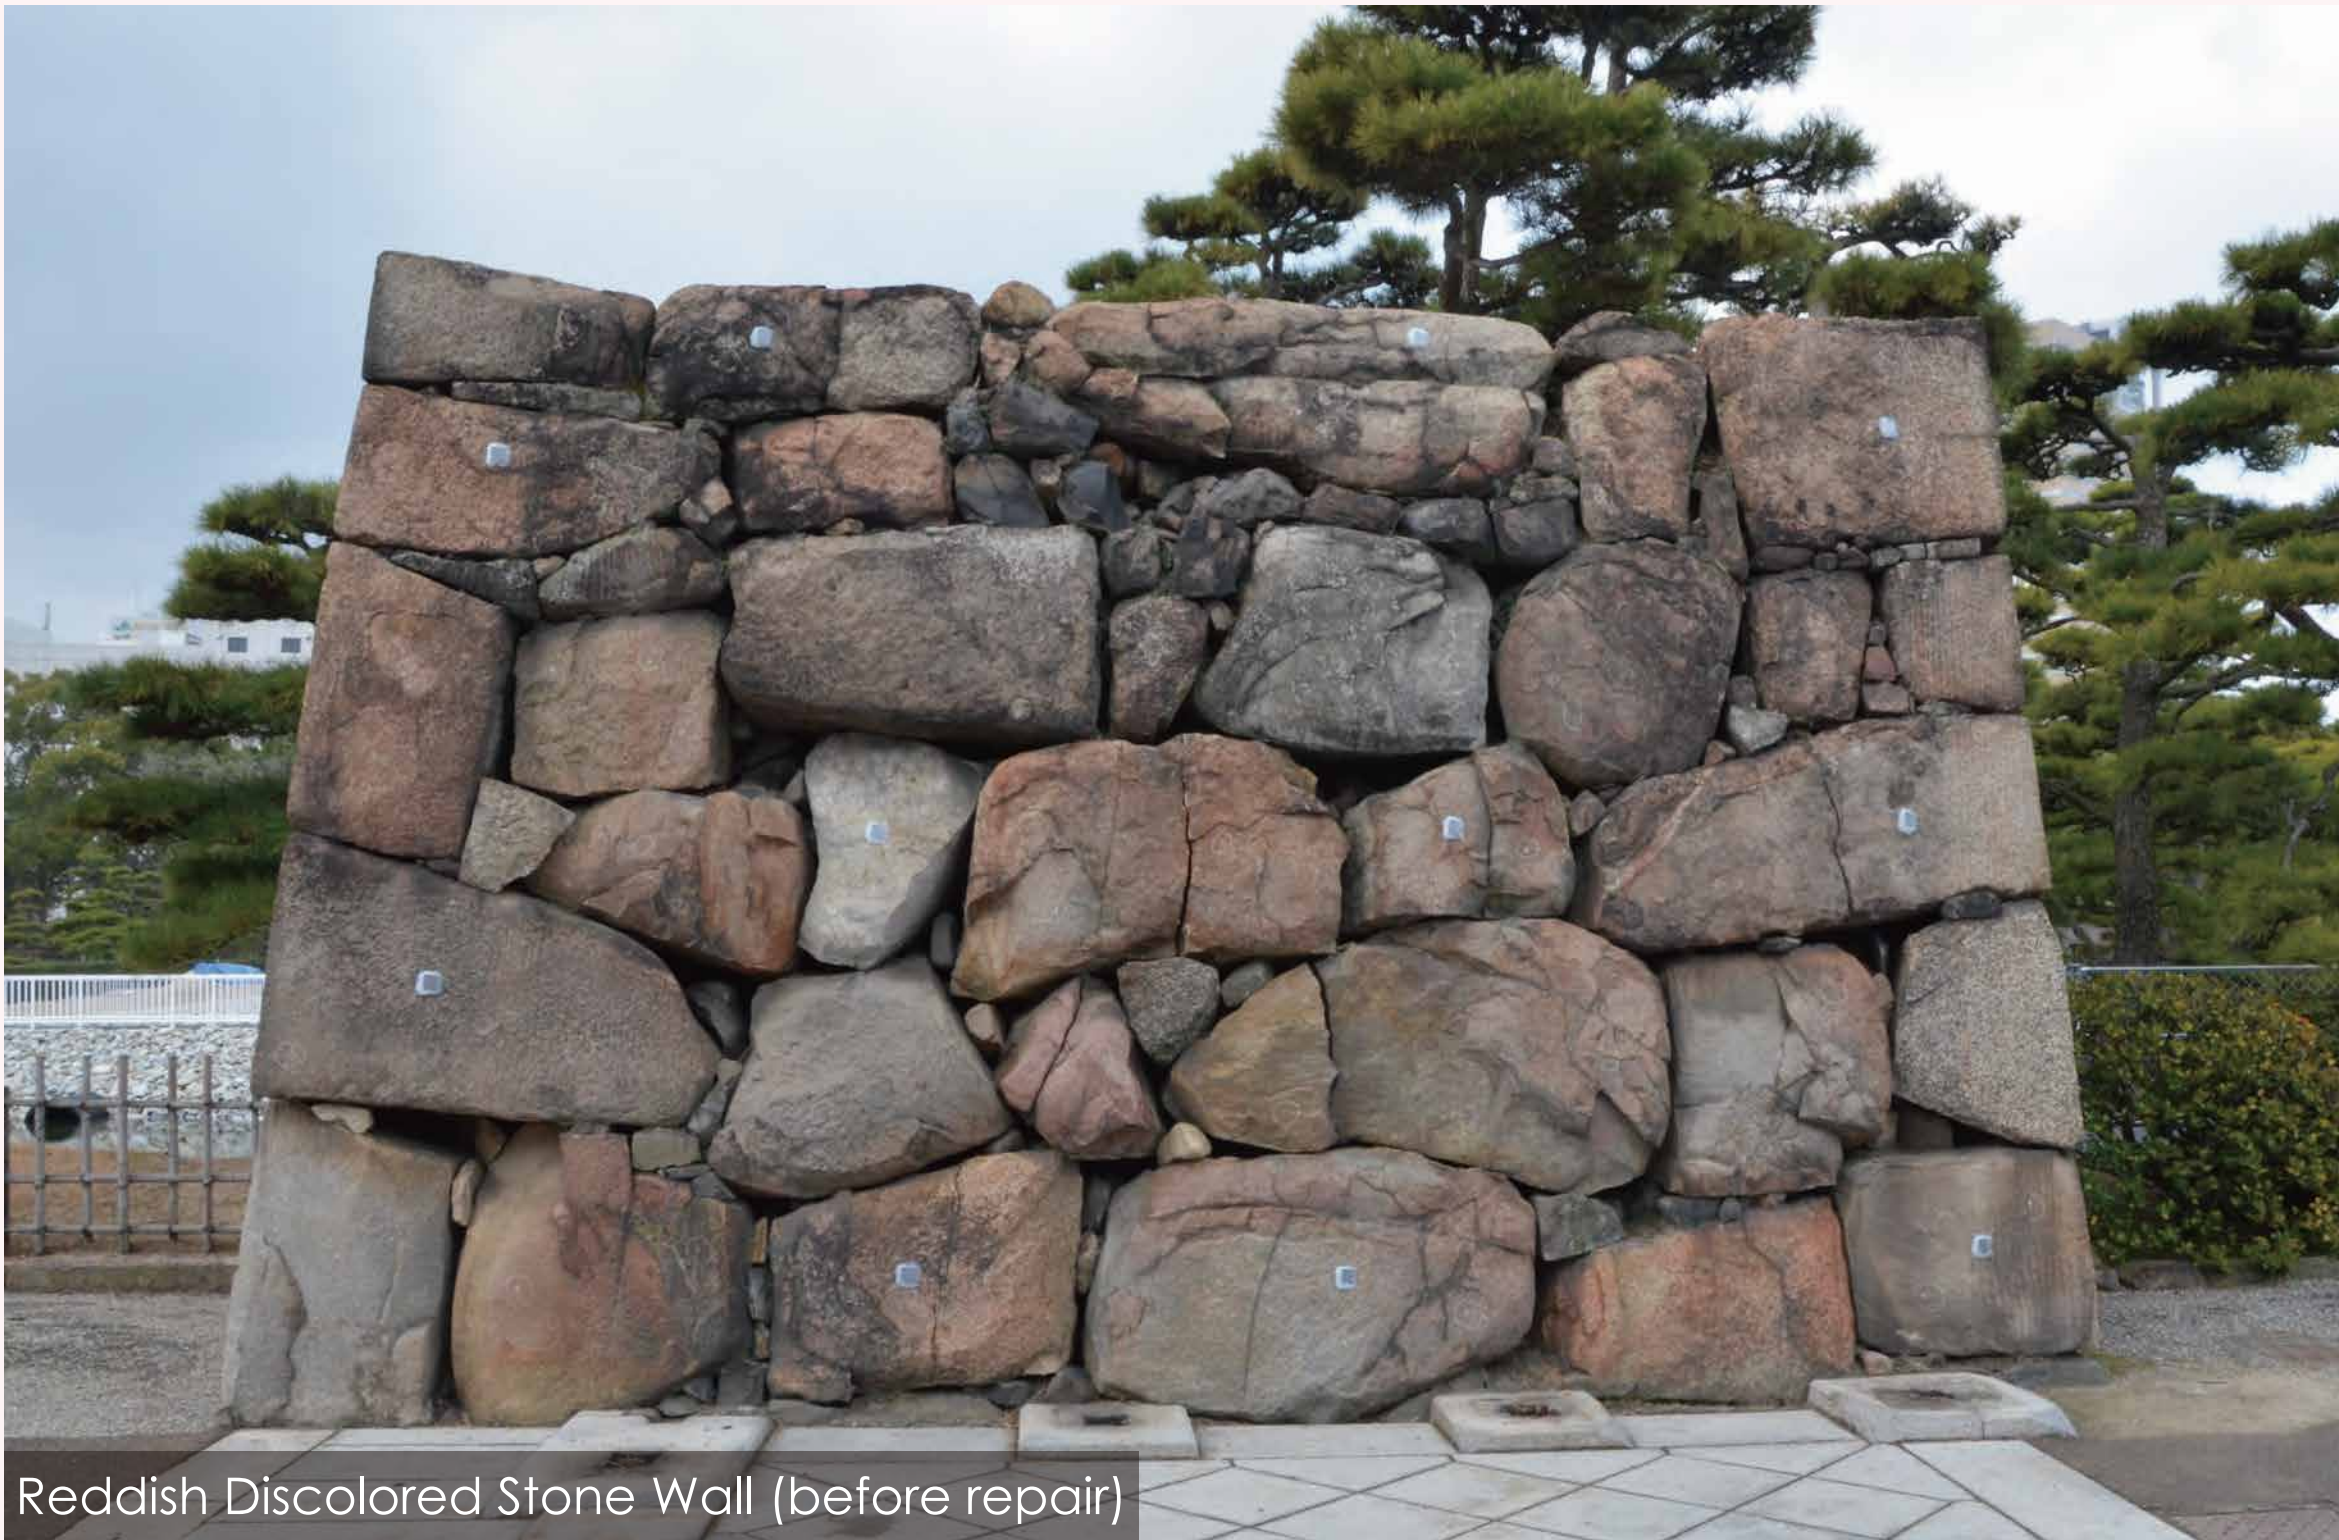
When the gate was lost to fire in the air raids, the *Ishigaki* [stone wall] was also severely damaged. The surface was discolored red, and cracks and broken stones were noticeable. The restoration of the Sakura Gomon began with repairing the stone wall that formed its foundation.

Reddish Discolored Stone Wall (before repair)

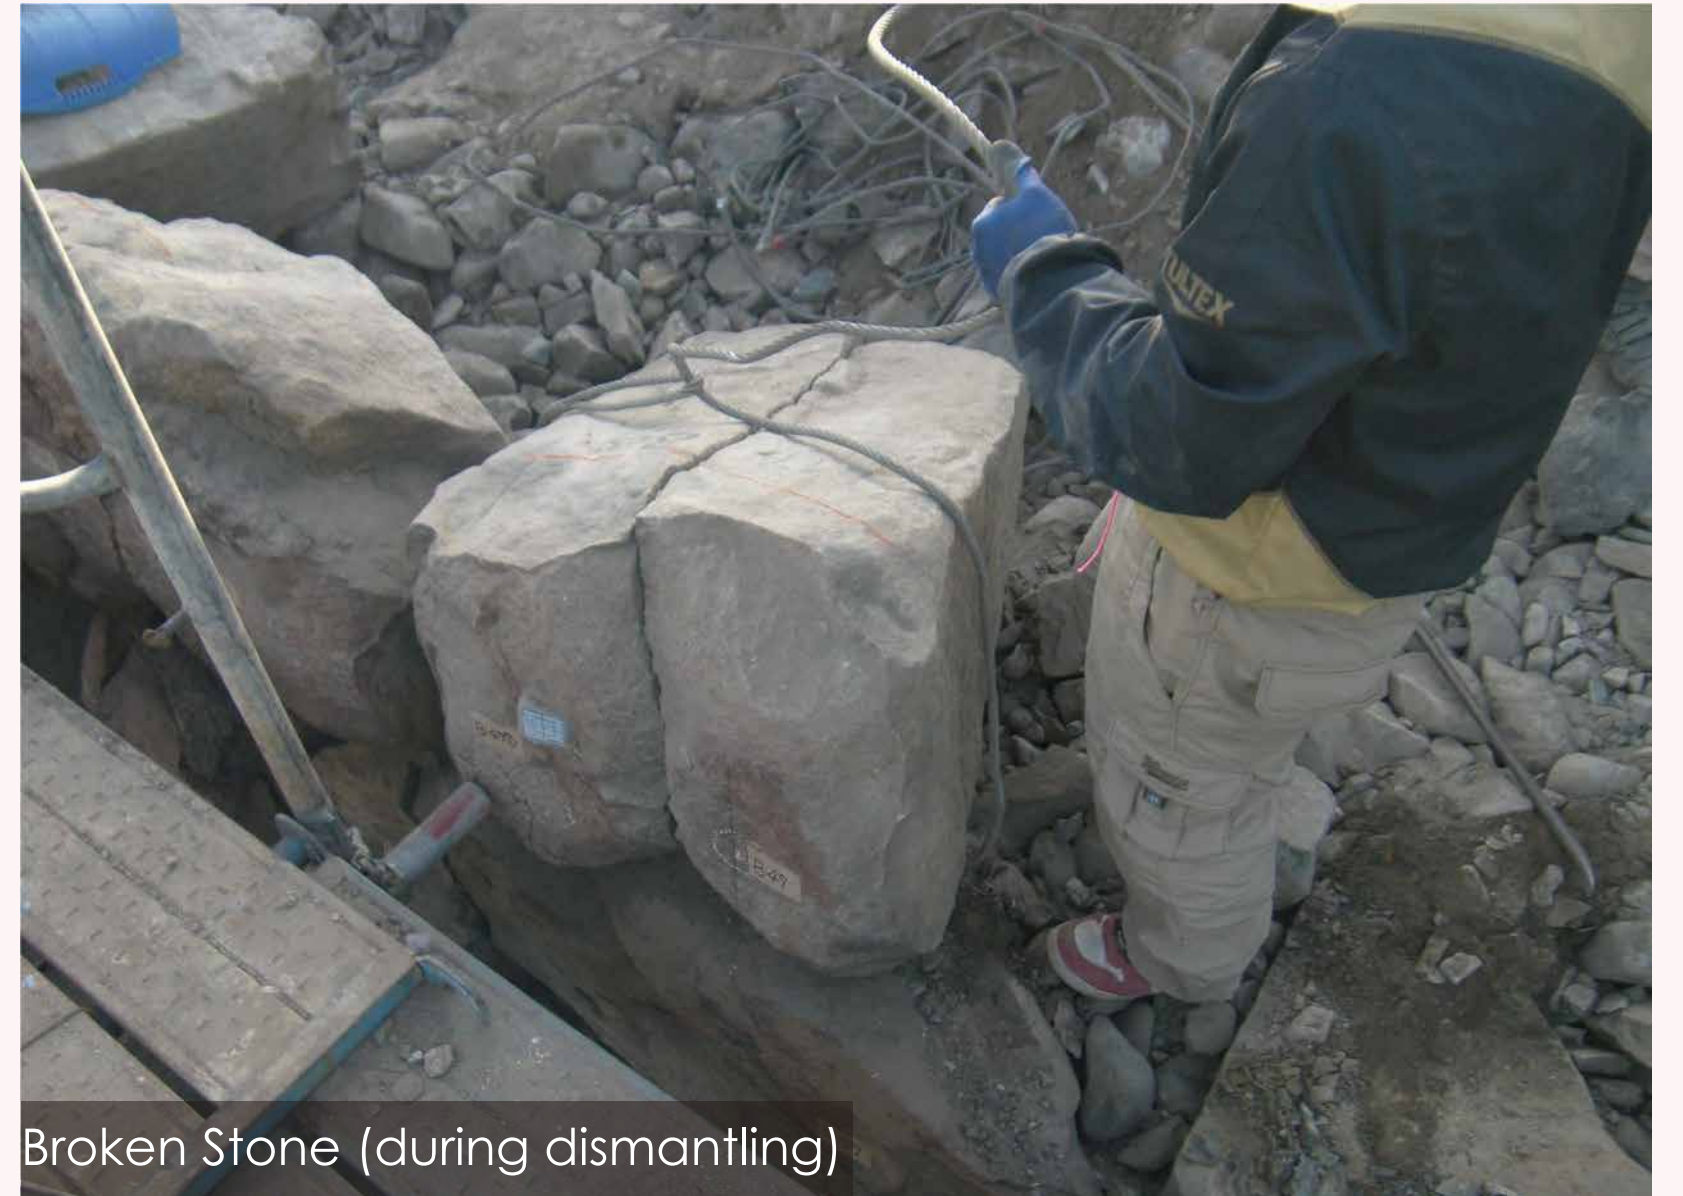
Broken Stone (during dismantling)

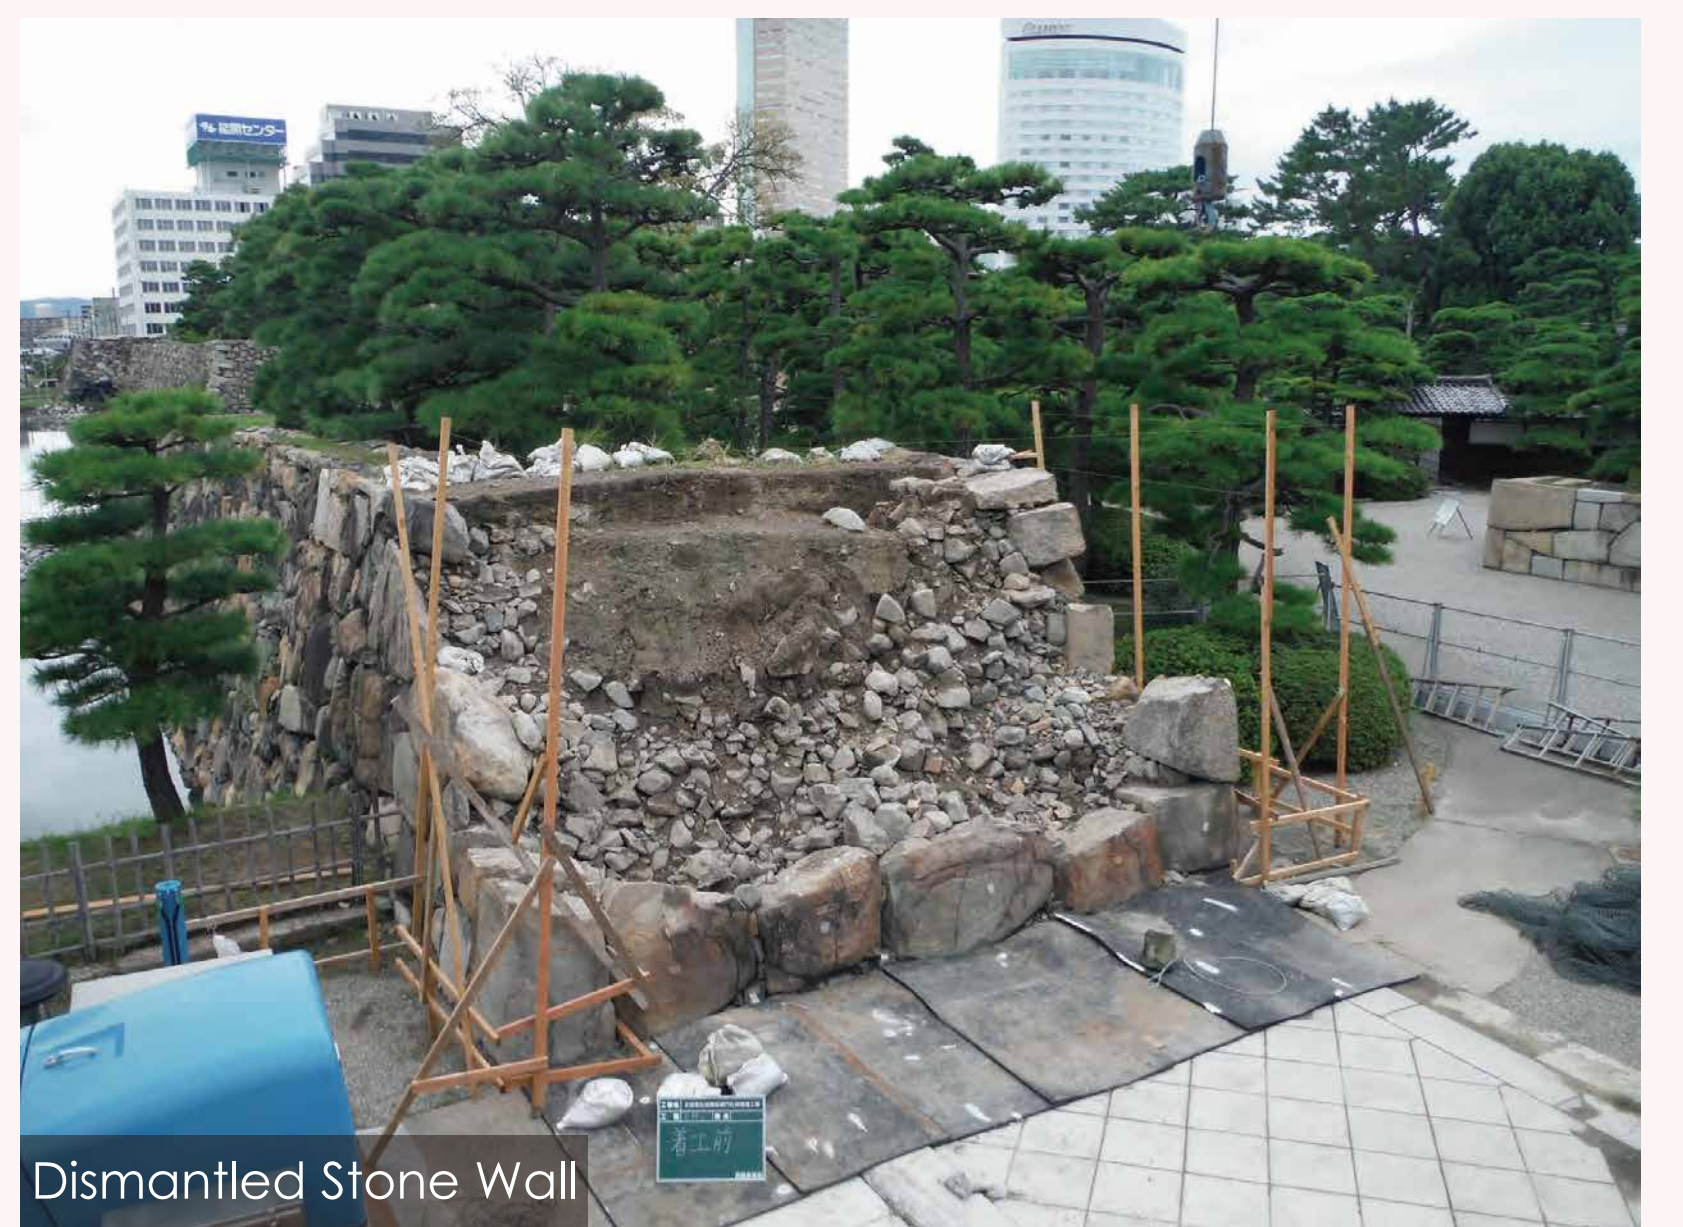
Dismantled Stone Wall

In repairing a stone wall, the original stones are usually re-stacked in their original positions. Only if it is unavoidable due to deterioration and other reasons, a part of it may be replaced with new stones. After much discussion, we decided to use the burned stones as much as possible for they were a trace of history of the bombing of Takamatsu at the Sakura Gomon. For this reason, many investigations and considerations went into the project. The strength of the stone was also examined by ultrasonic waves and other methods. Broken stones were reused by connecting them with bolts and pins. In addition, the stone wall was tested to verify its stability when the gate structure was revived. Then, the stones were re-stacked on the site.
