Basis for Restoration of Sakura Gomon

Rebuilding Historic Structure

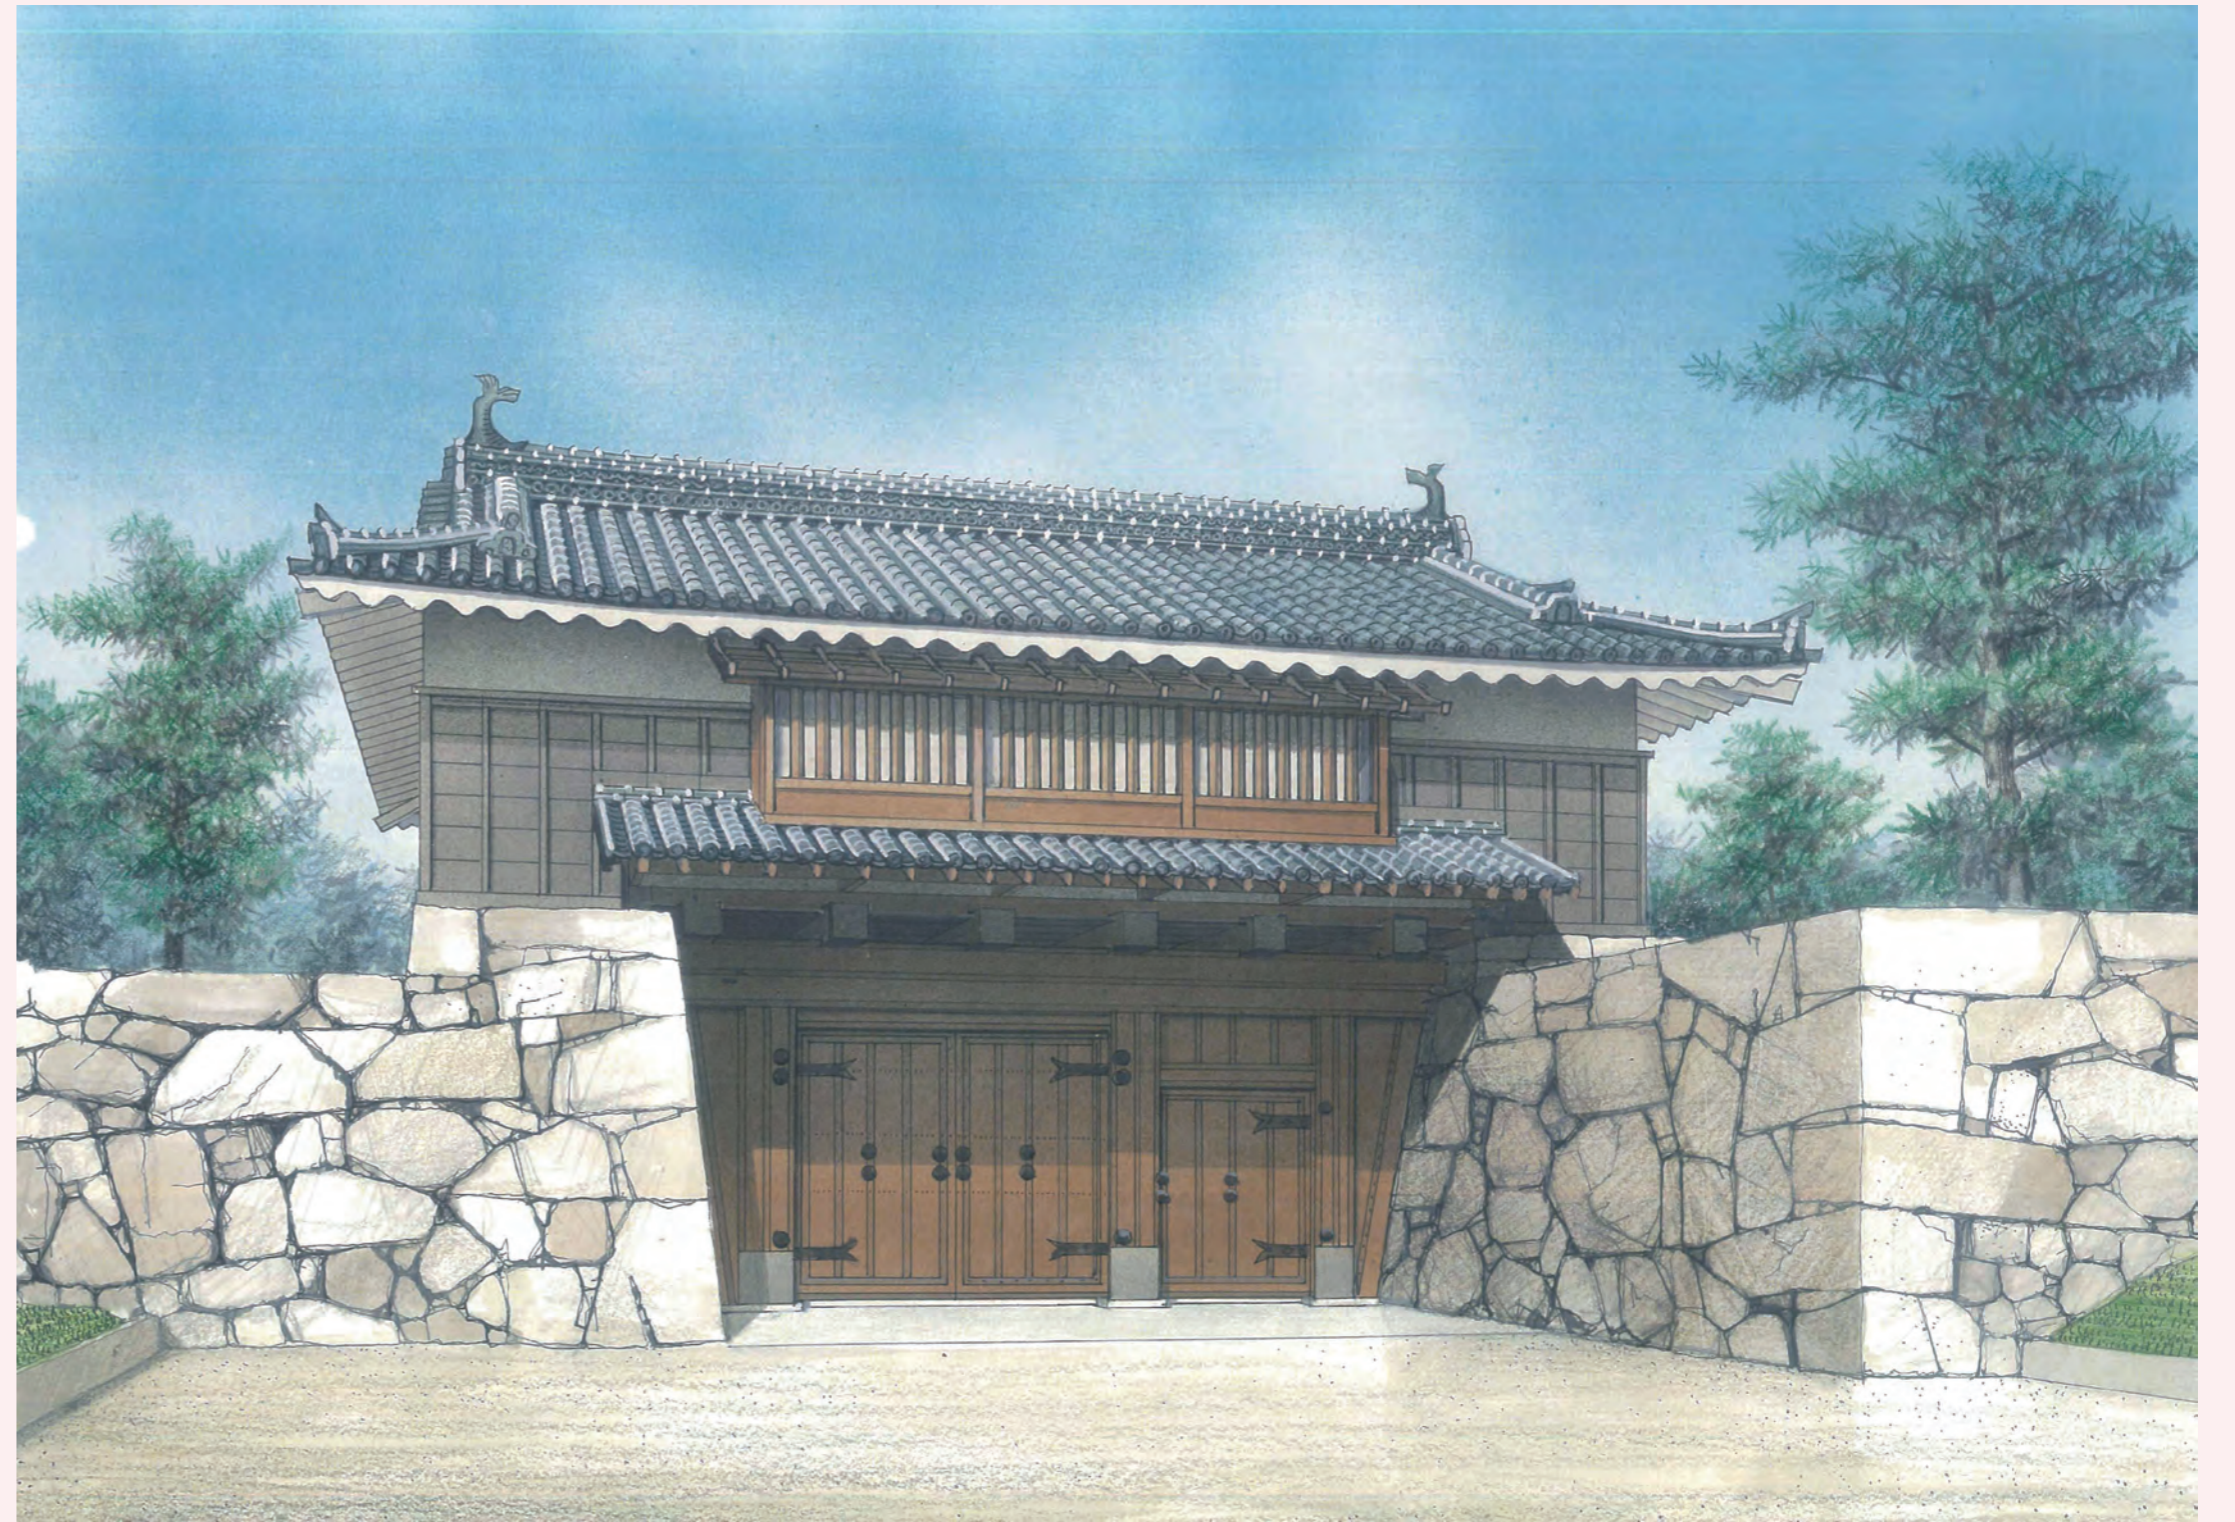
Architectural Rendering of Sakura Gomon at the Time of Design

In order to restore a historic structure at a historical landmark, it is necessary to collect information and conduct research to accumulate evidence for restoration and to reproduce the structure as faithfully as possible to the original appearance. Sakura Gomon is the first example of reconstruction at the historic site of Takamatsu Castle. No plans or models have survived, so a restoration plan was created based on old photographs and traces of the gate that remain at the site.

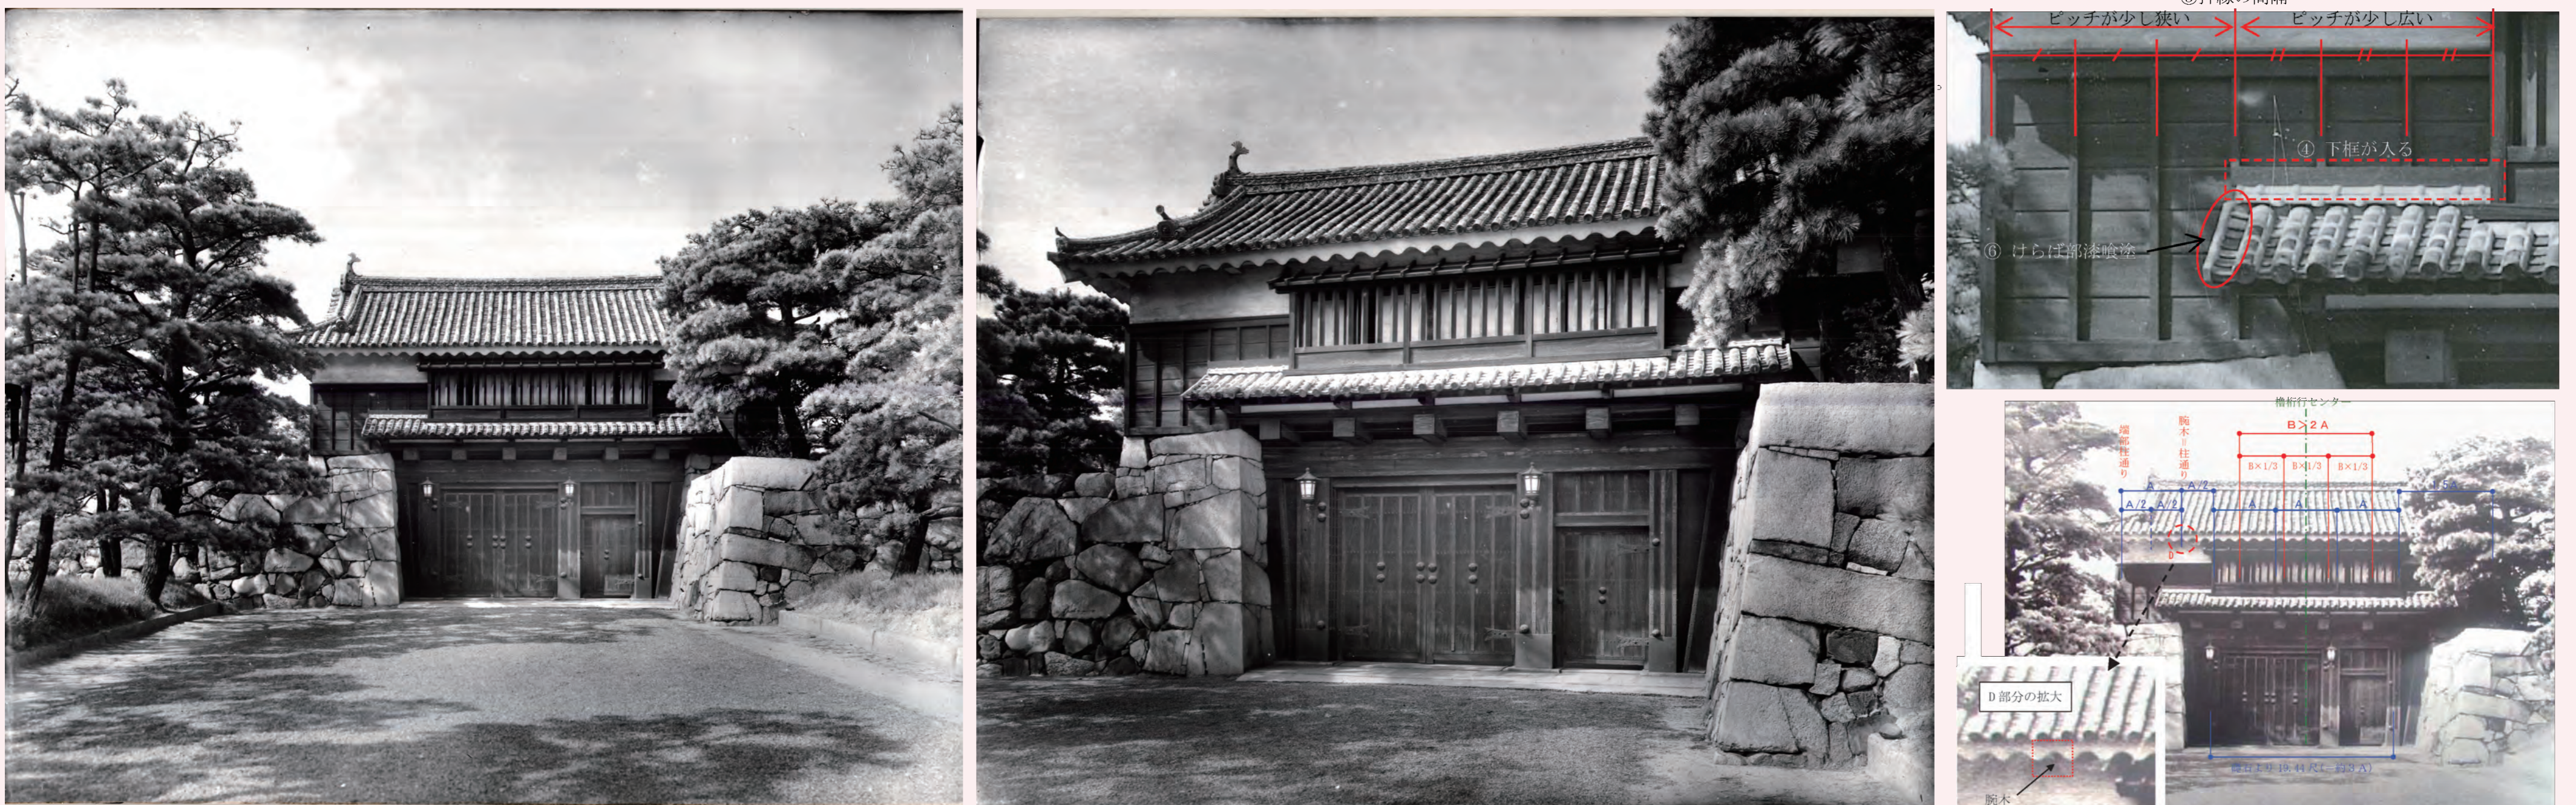
Old Pictures of the Sakura Gomon (Courtesy of the Nara National Research Institute for Cultural Properties) and an Example of Photo Analysis

During the collection of materials for restoration studies, very clear photographic plates on glass were found. Because of the ability to see details, it became possible to analyze the photos, calculate the dimensions, and observe design in detail.

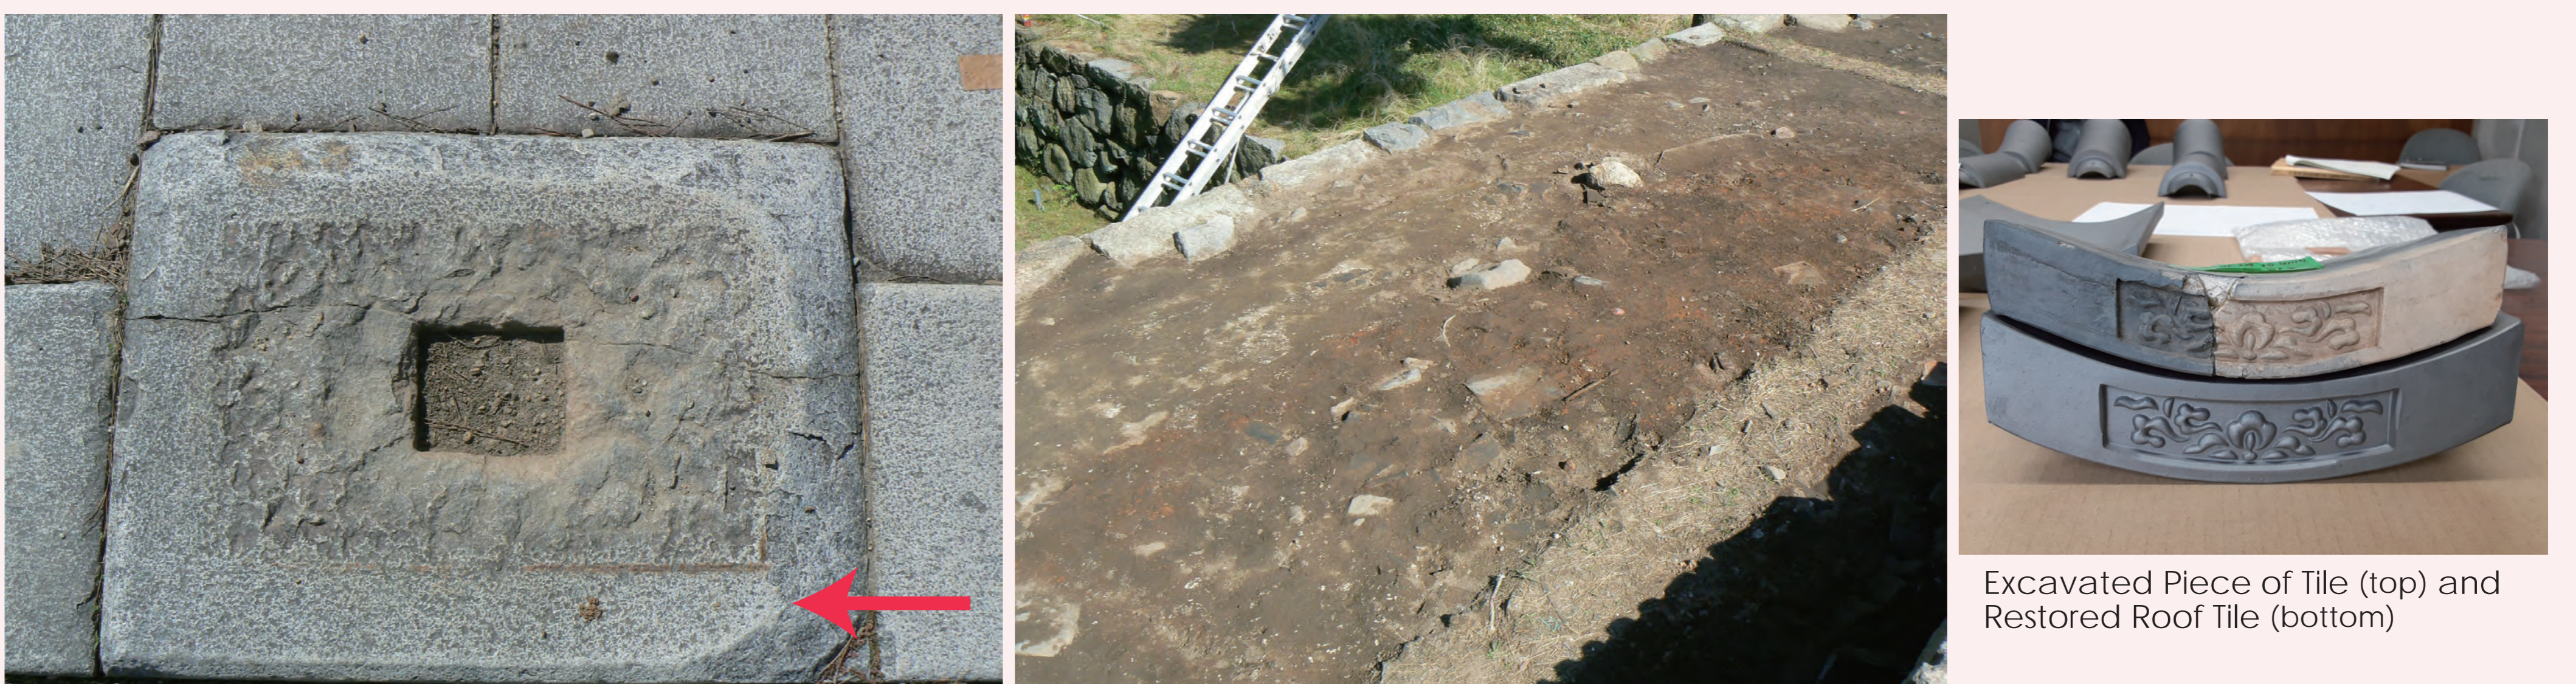
Traces of Column on Foundation Stone (Rust of metal hardware wrapped around the base)

Layer of Earth Reddened by Air Raids

Excavated Piece of Tile (top) and Restored Roof Tile (bottom)

The gate was lost in the air raids, but traces of the original structure were left on the site. The foundation on which the pillars were placed has traces of metal fittings wrapped around the base of the posts as rust, indicating the dimensions. Excavations on the stone wall revealed roof tiles, earthen walls, nails, and other building materials in the layers that had been burned red by the firebombing, providing the basis for the reconstruction.
