Basis for Restoration of Sakura Gomon

Rebuilding Historic Structure

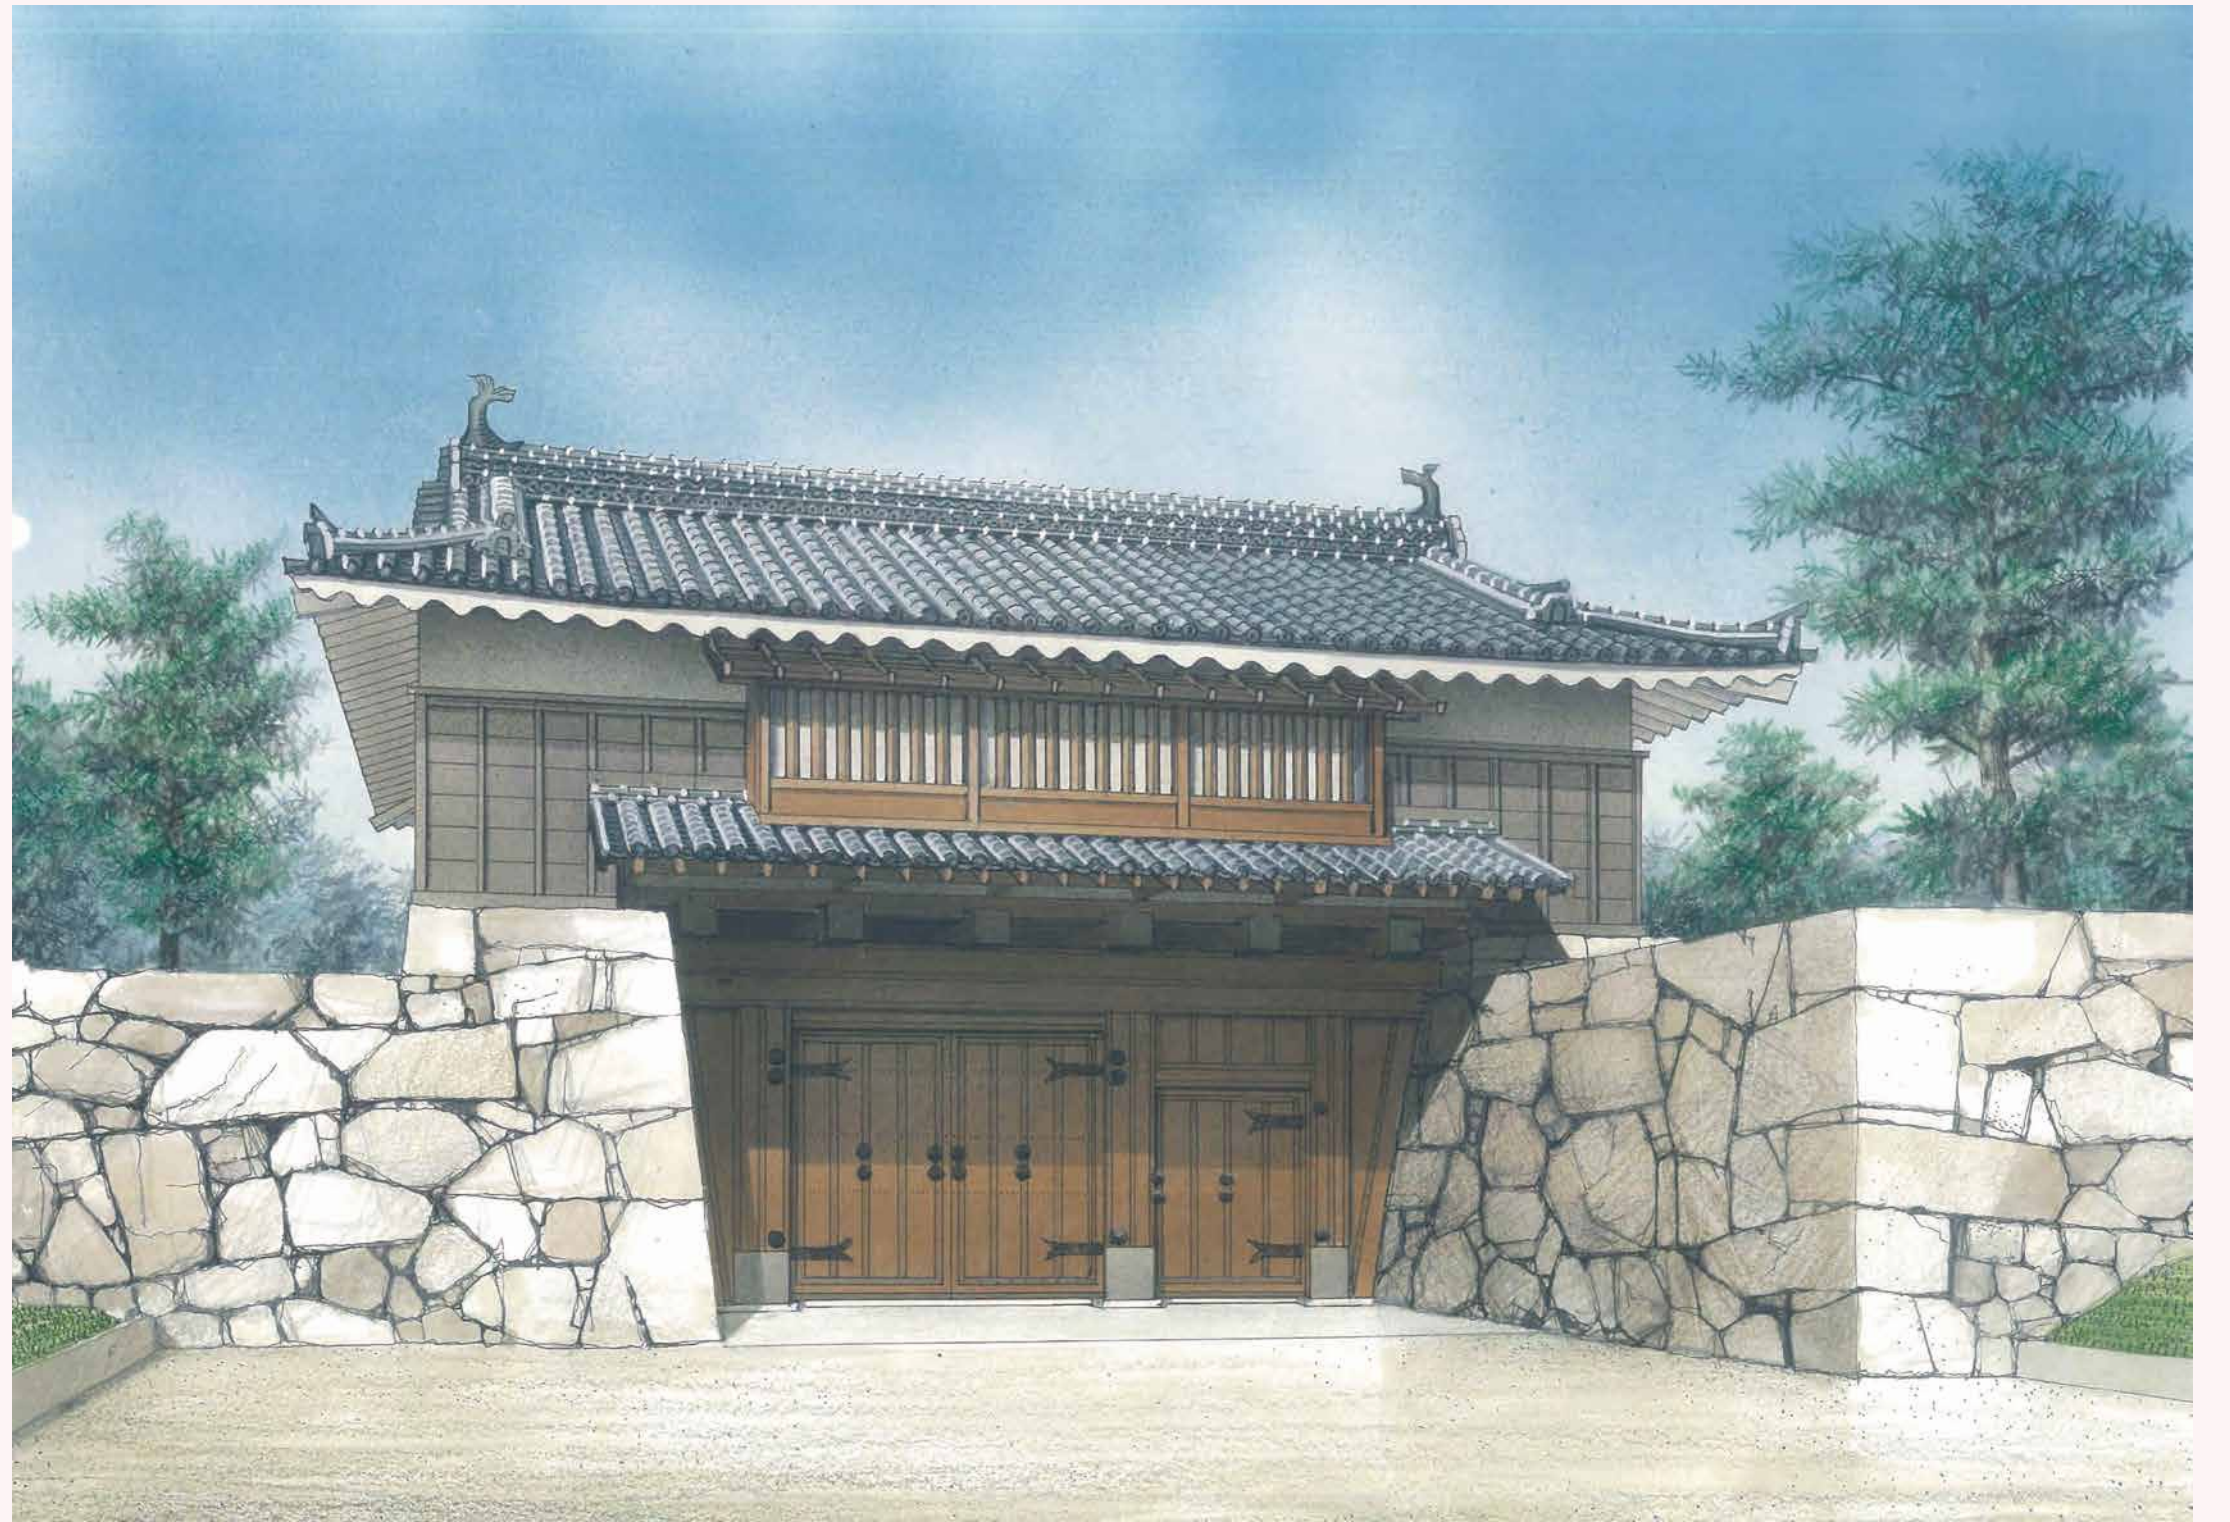
Architectural Rendering of Sakura Gomon at the Time of Design

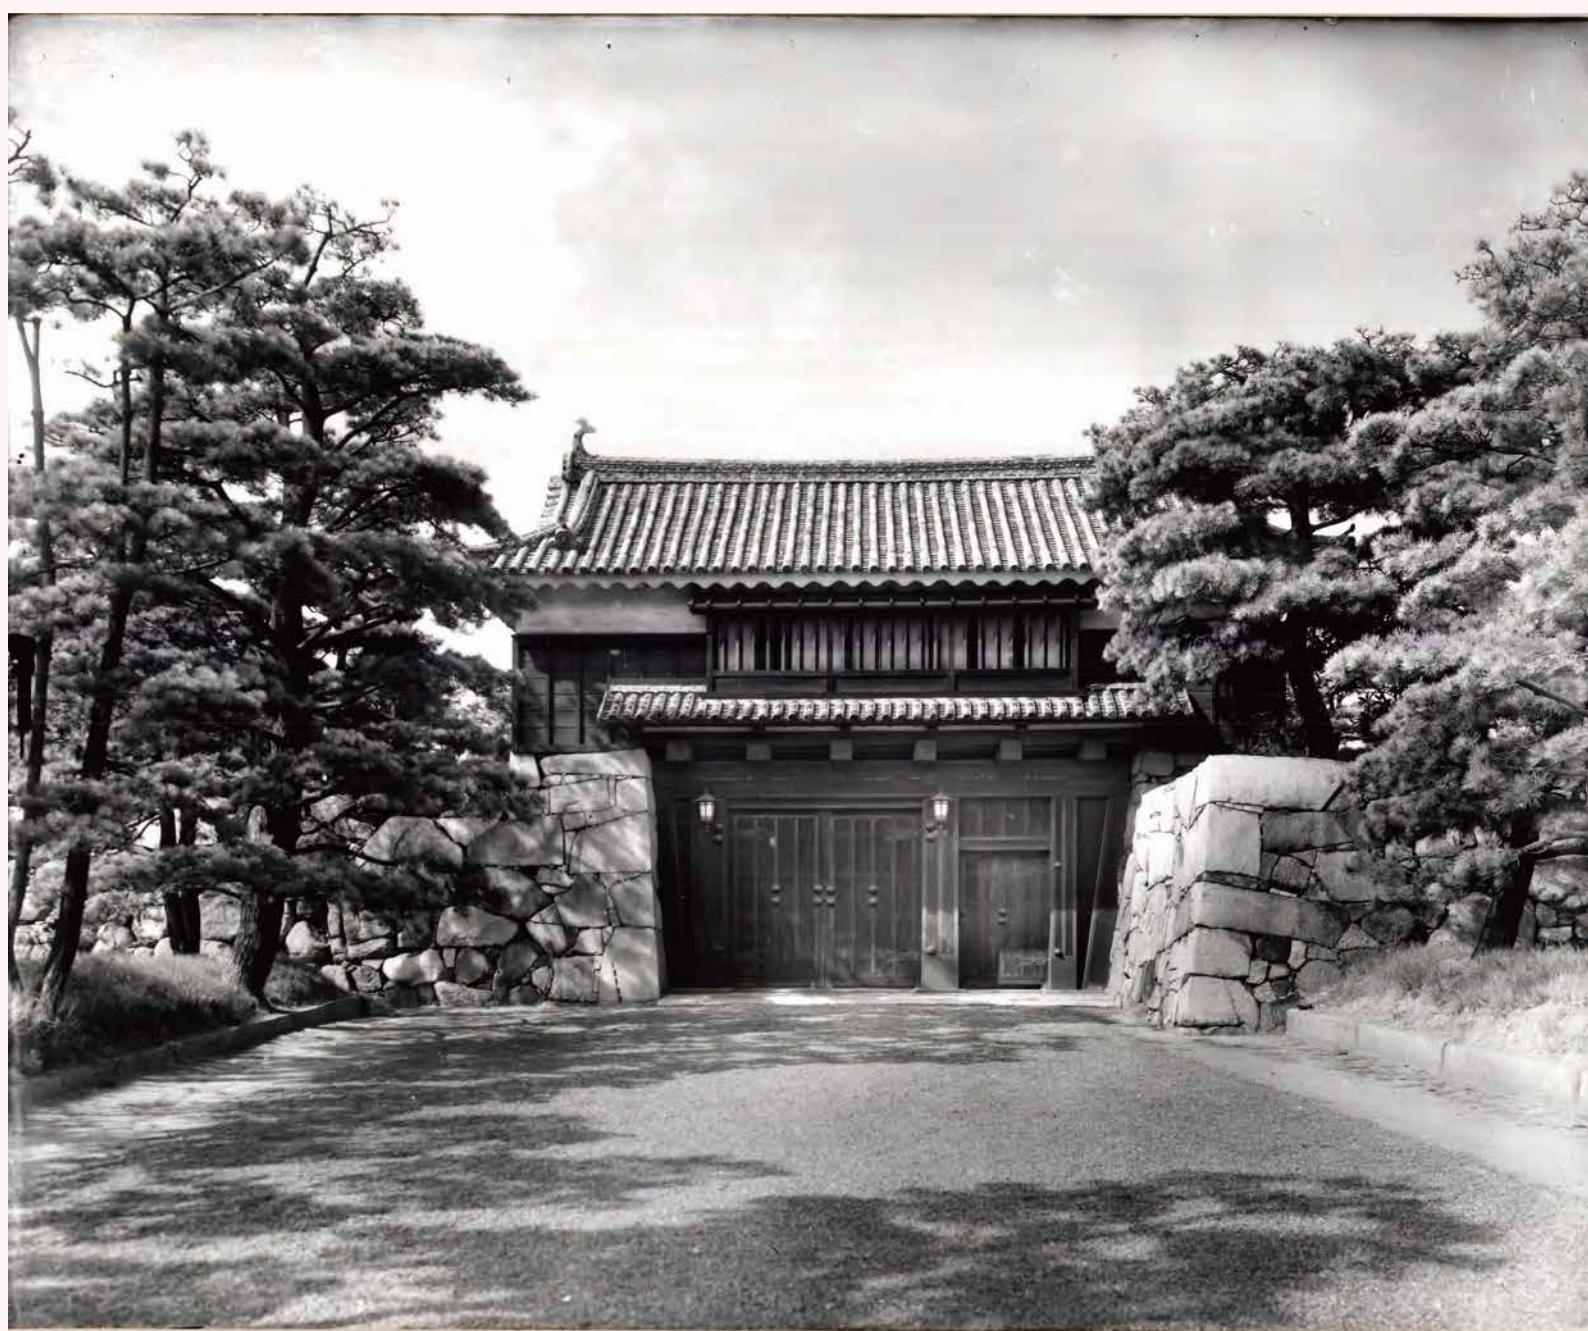
Old Pictures of the Sakura Gomon (Courtesy of the Nara National Research Institute for Cultural Properties) and an Example of Photo Analysis

During the collection of materials for restoration studies, very clear photographic plates on glass were found. Because of the ability to see details, it became possible to analyze the photos, calculate the dimensions, and observe design in detail.

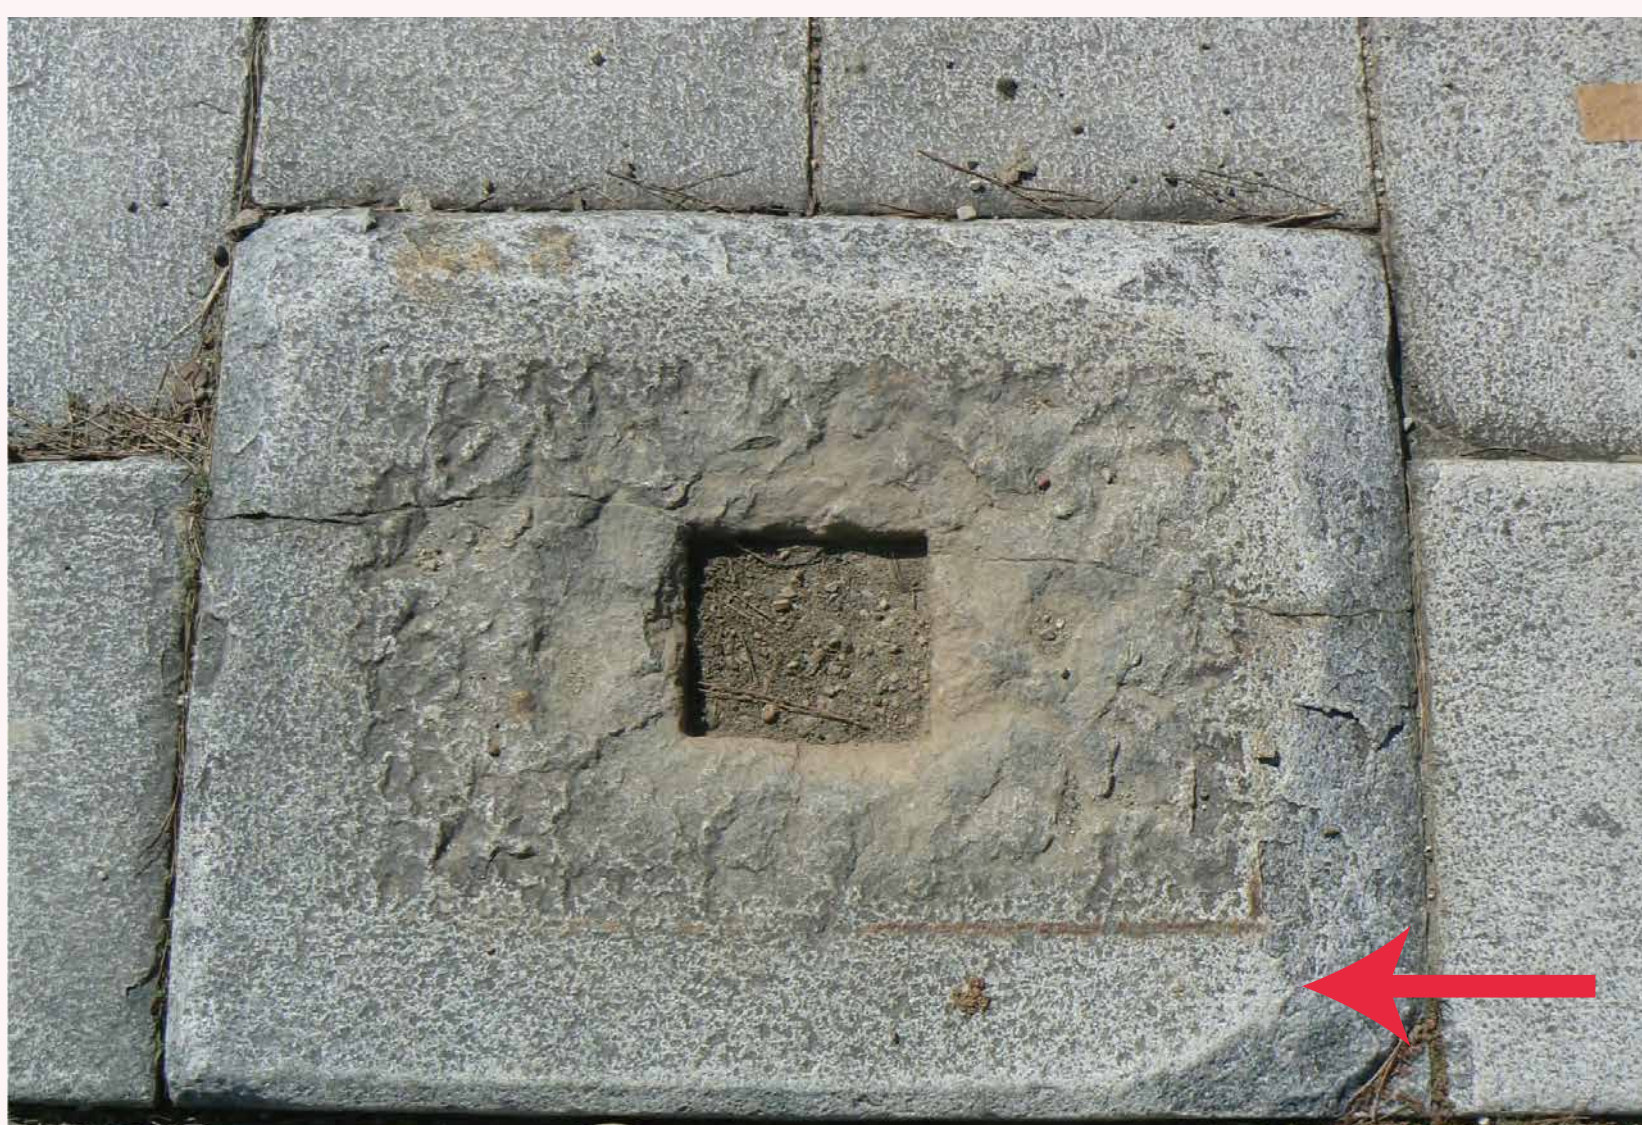
Traces of Column on Foundation Stone (Rust of metal hardware wrapped around the base)

The gate was lost in the air raids, but traces of the original structure were left on the site. The foundation on which the pillars were placed has traces of metal fittings wrapped around the base of the posts as rust, indicating the dimensions. Excavations on the stone wall revealed roof tiles, earthen walls, nails, and other building materials in the layers that had been burned red by the firebombing, providing the basis for the reconstruction.

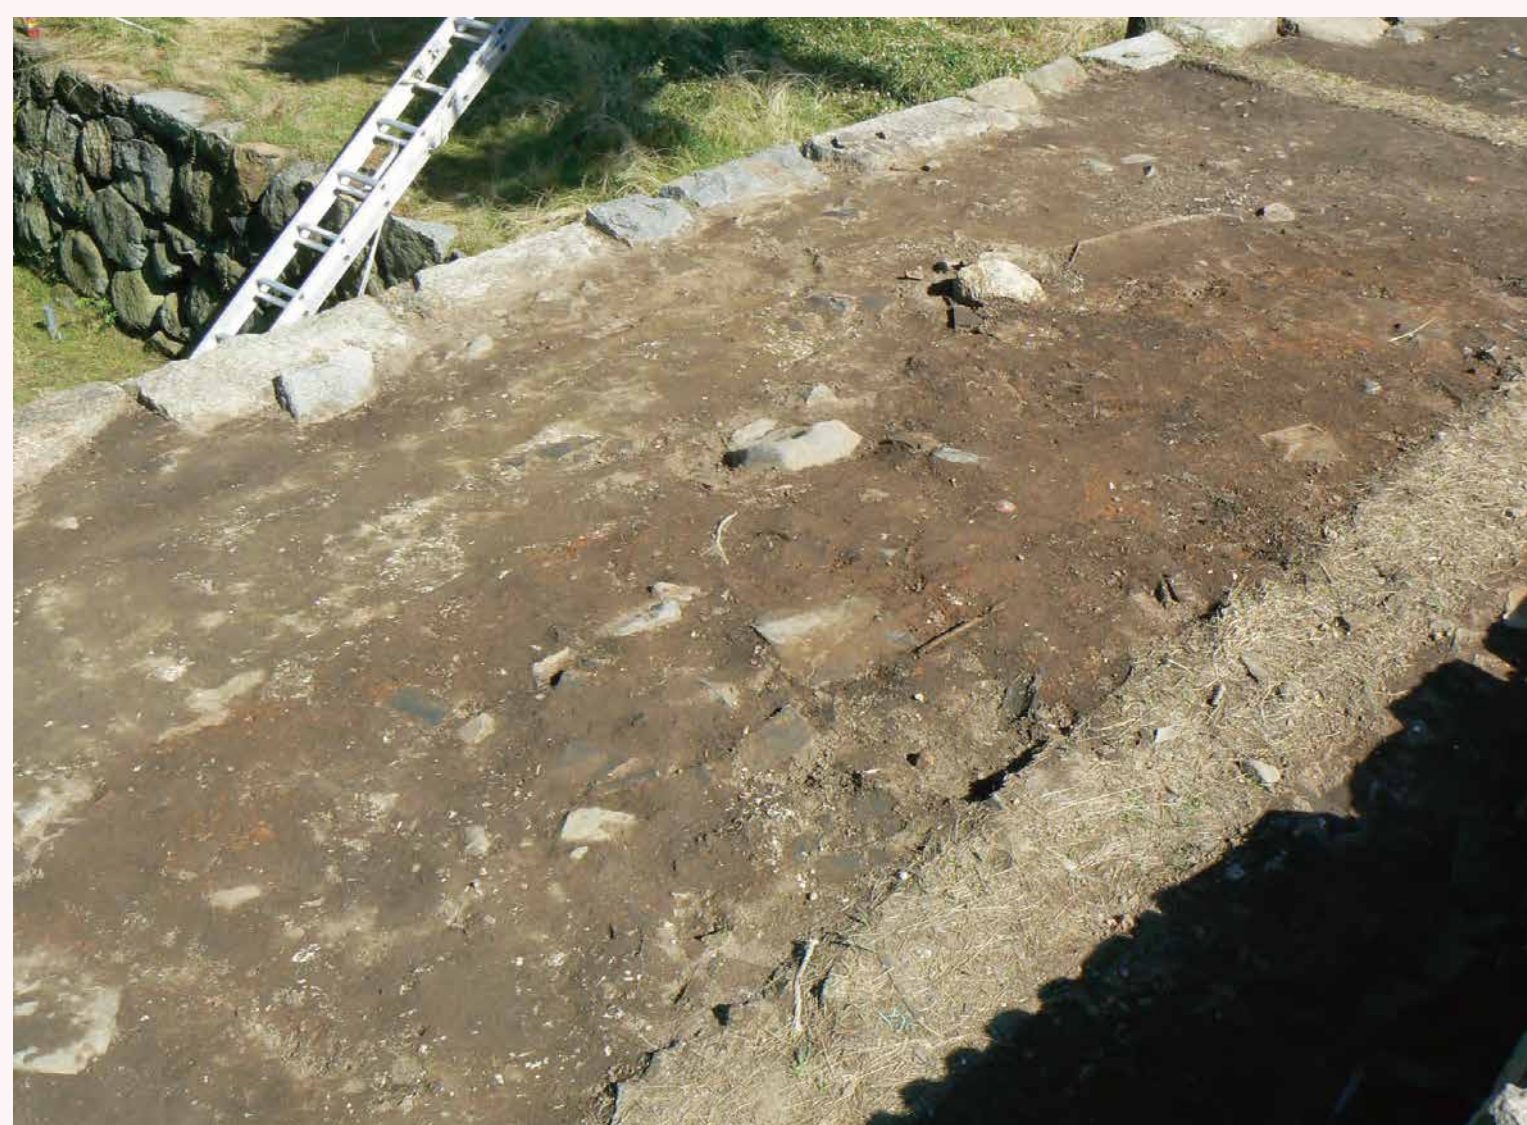
Layer of Earth Reddened by Air Raids

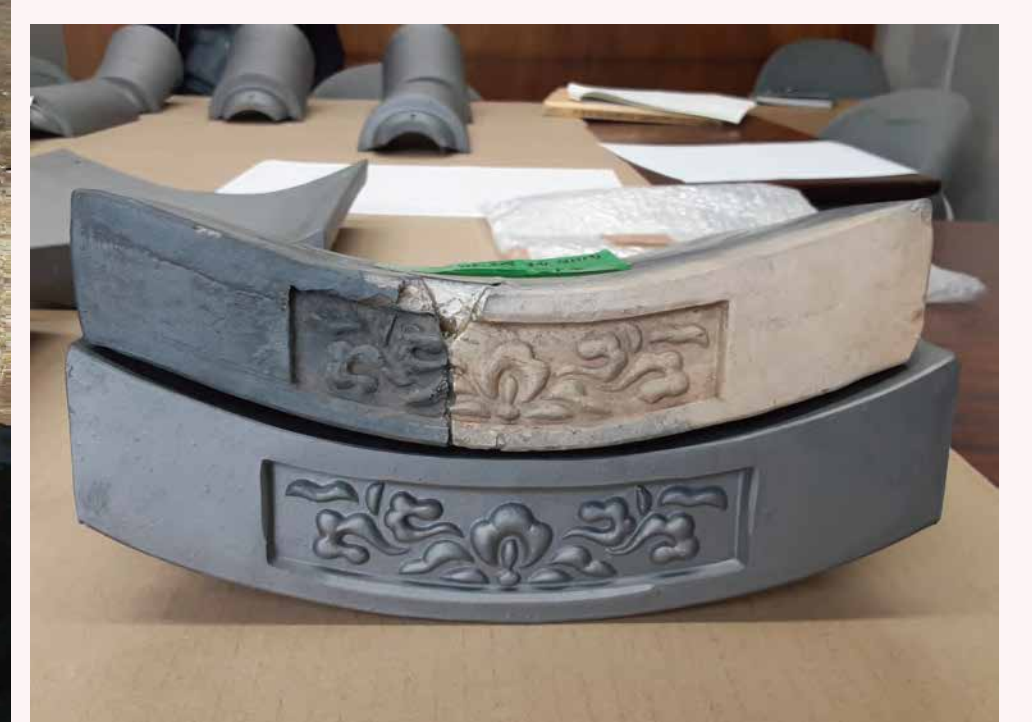
Excavated Piece of Tile (top) and Restored Roof Tile (bottom)
