Safety as Park Facility

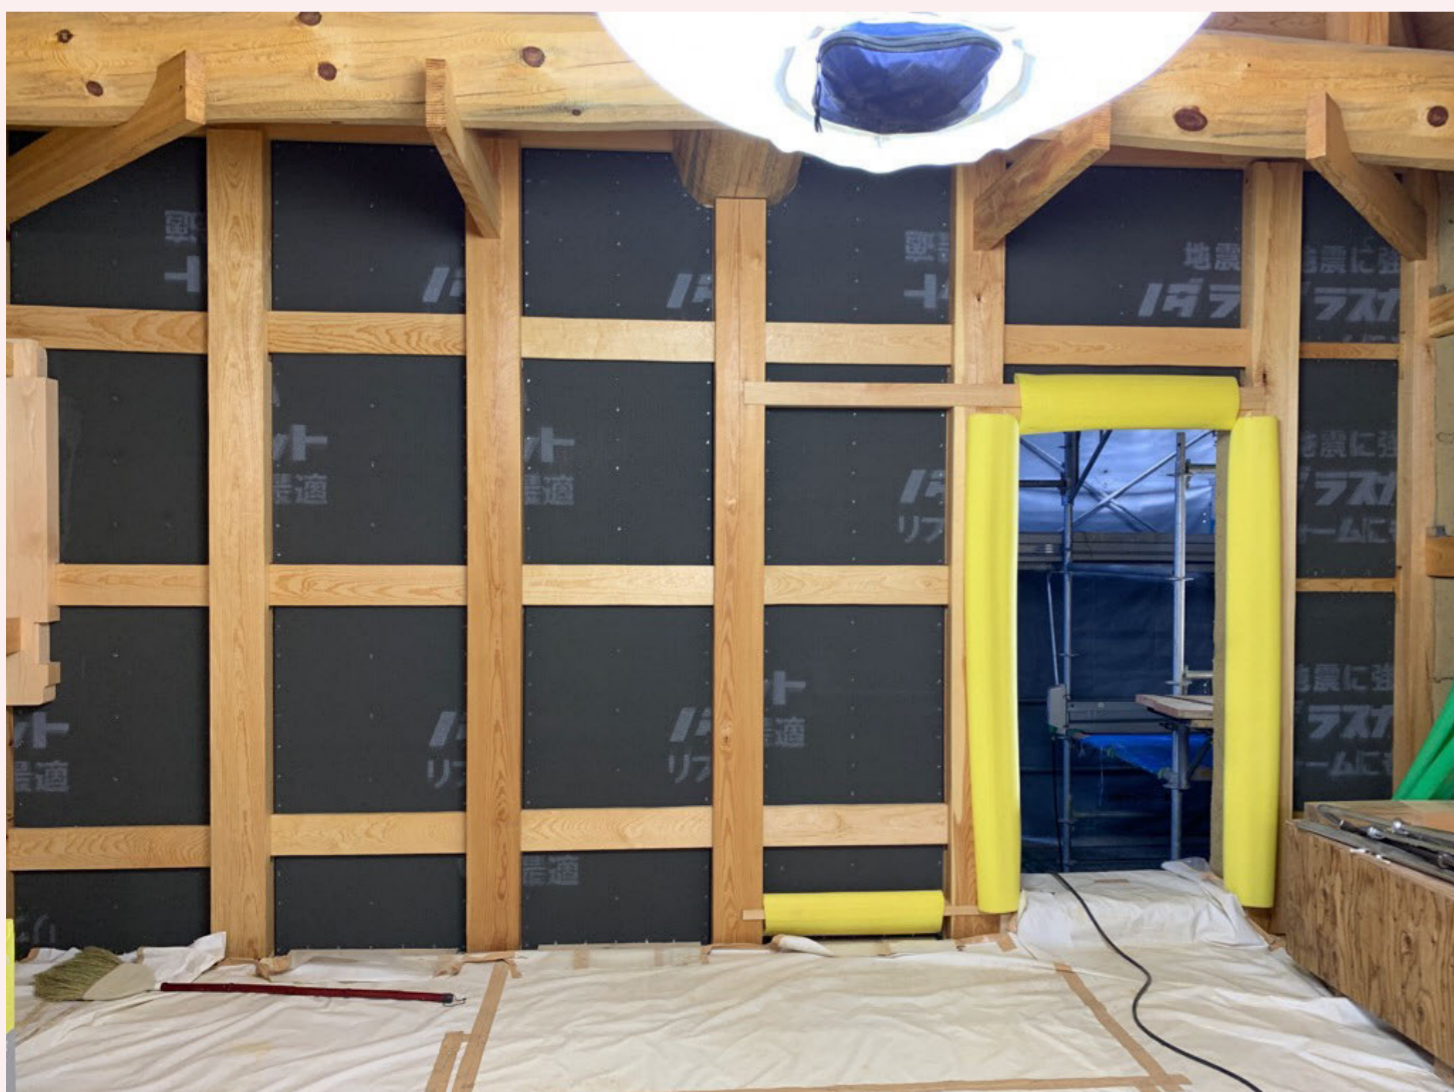
Structural Plywood Installed in the Wall

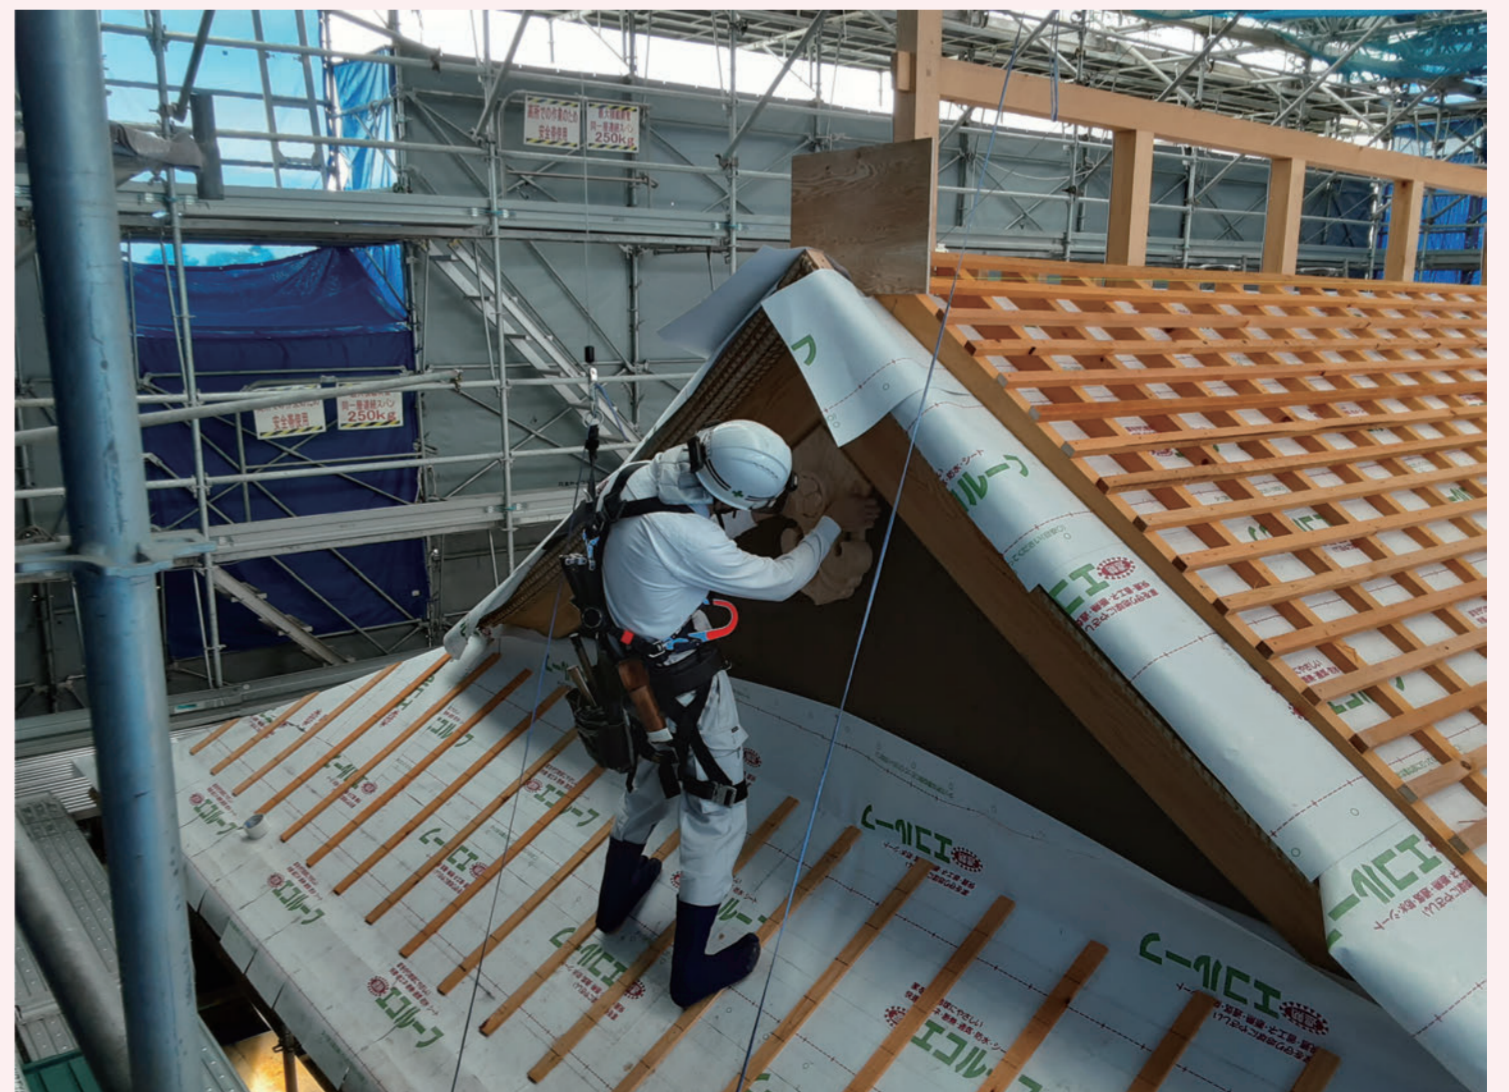
Insulation / Ventilation / Waterproof Sheets Installed under Roof Tiles
