Fabrication & Inspection of Roof Model

Examination with Model

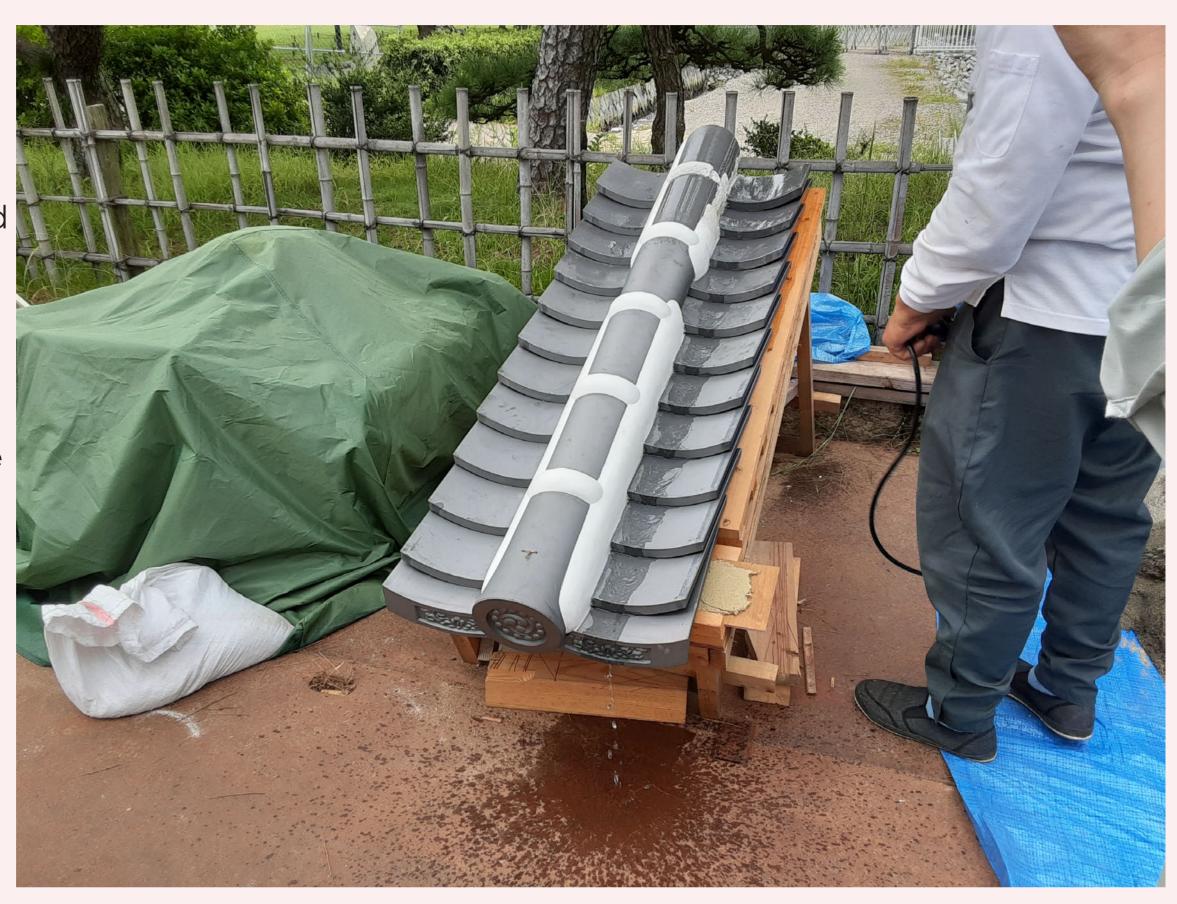
Rainwater Drainage Test Using Model

the blueprints. The shape of the plaster to be applied as a finish over the roof tiles was determined by creating multiple patterns and comparing them with old photographs. At the same time, experiments were conducted to examine whether the building could drain well without water entering the structure when it rained.

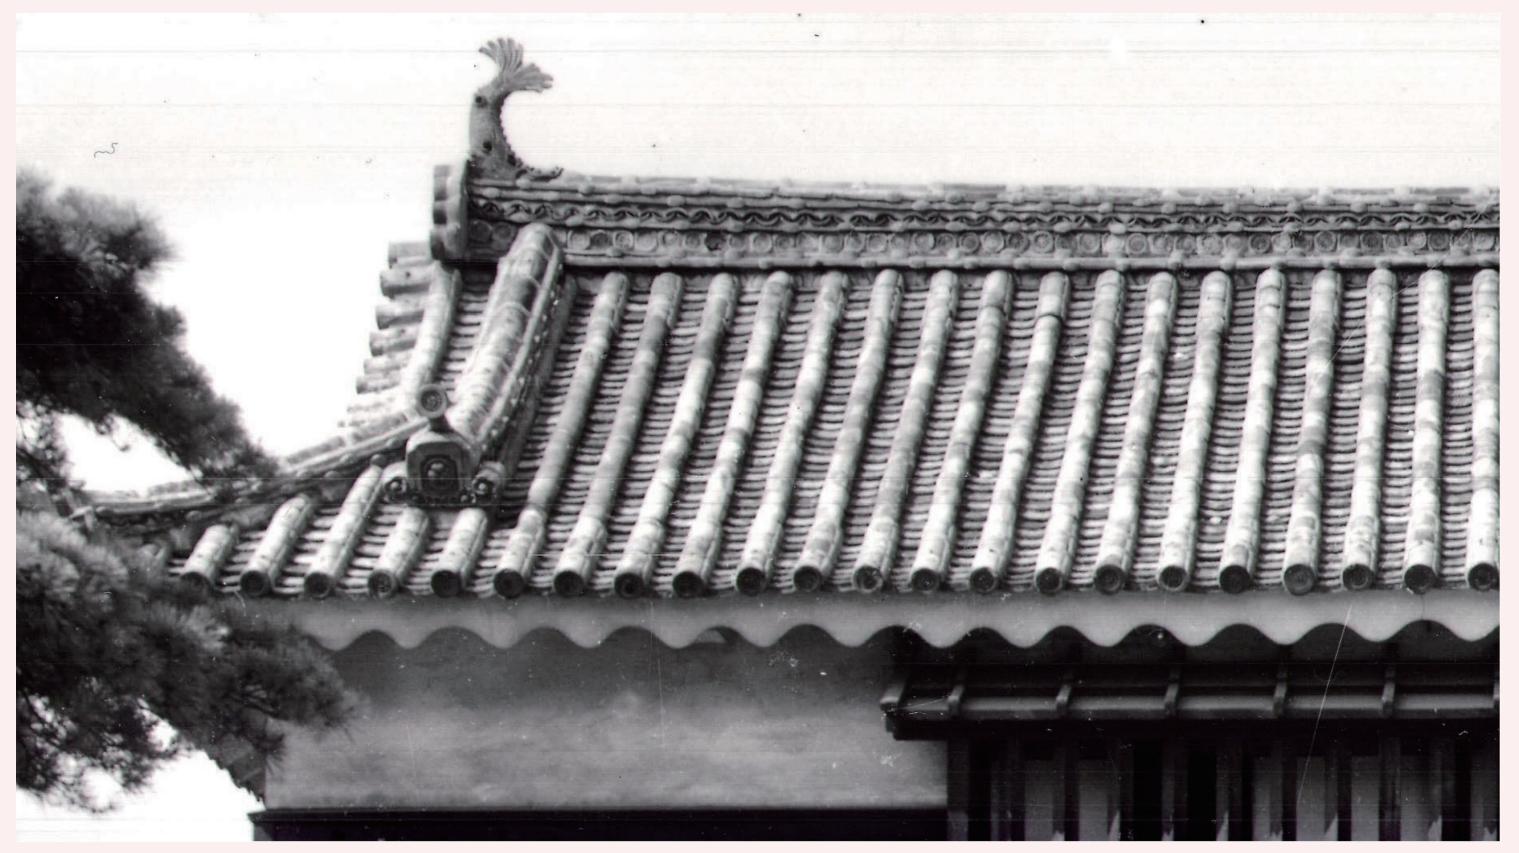
Shape of the Roof Seen on Old Photograph (Courtesy of the Nara National Research Institute for Cultural Properties, Enlarged)
