Updating Rationale for Restoration

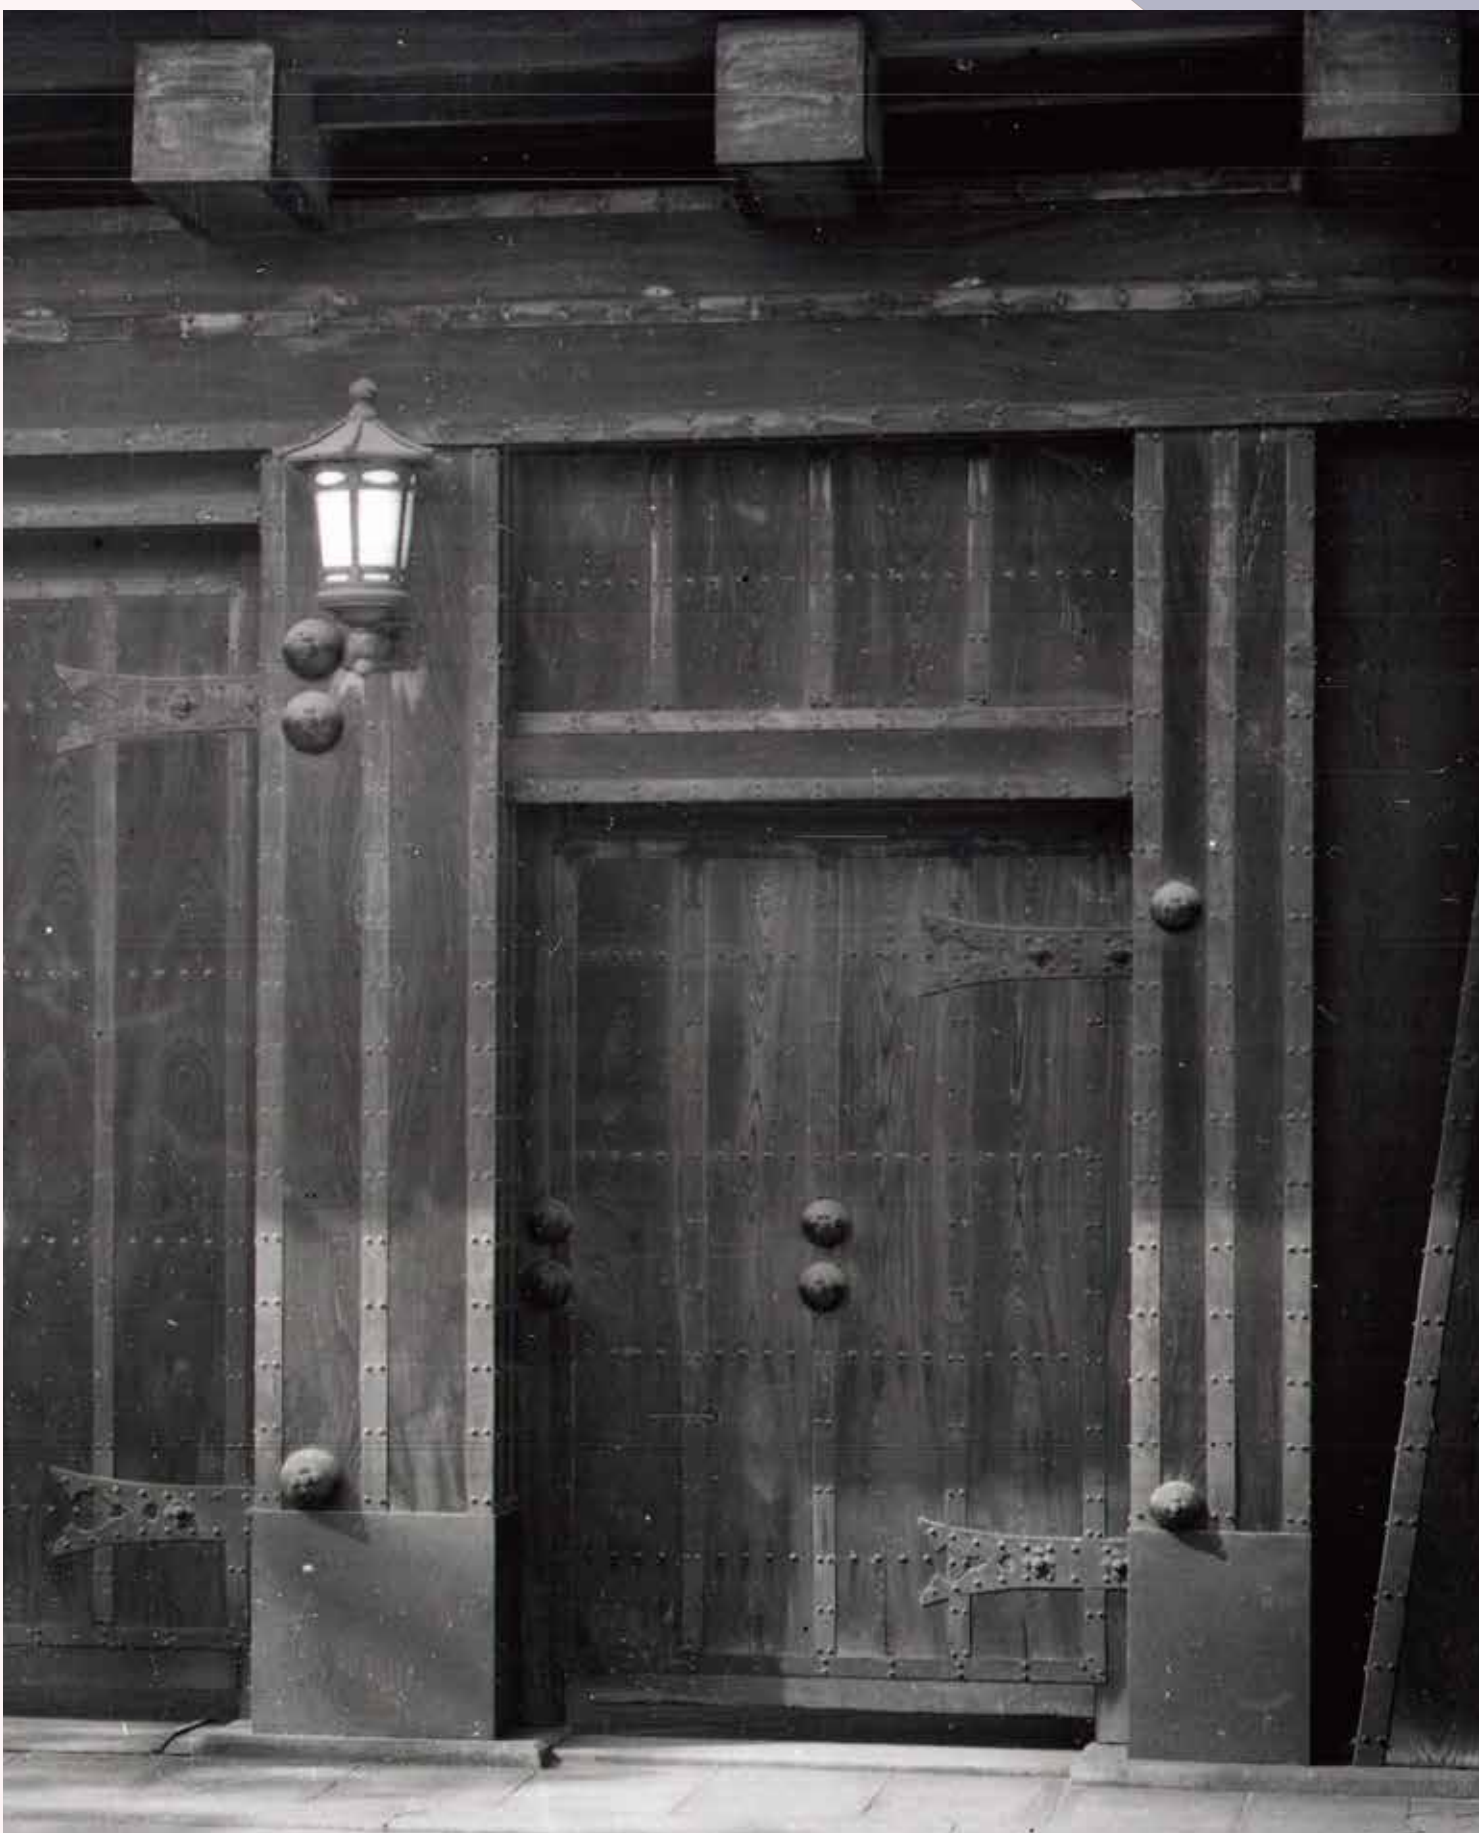
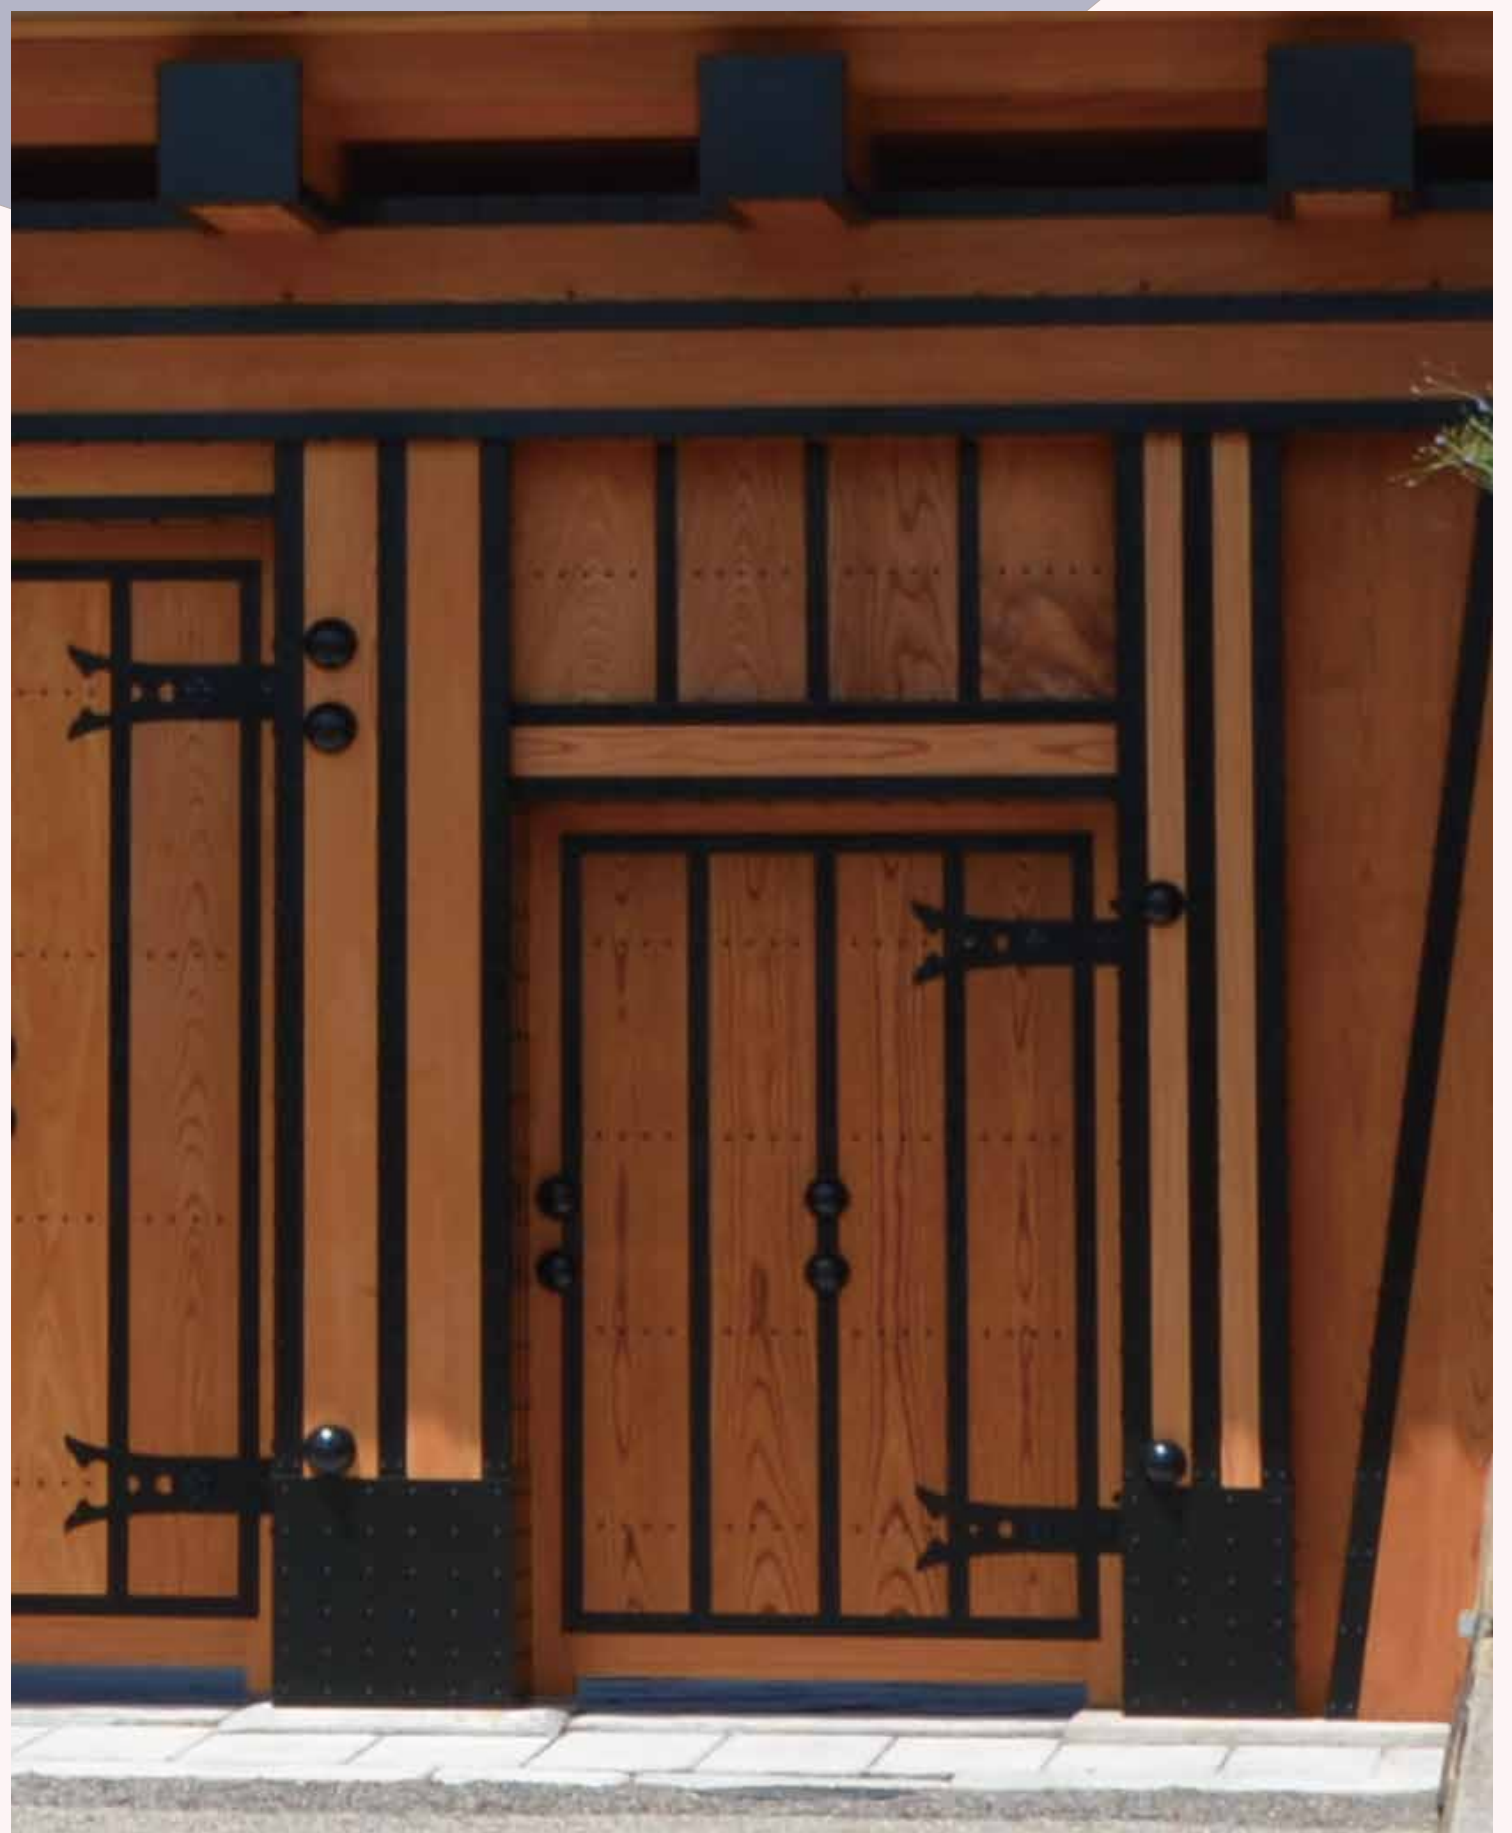
Pillar in Old Photograph (Left, Courtesy of the Nara National Research Institute for Cultural Properties, Enlarged) as the Basis and Restored Sakura Gomon (Right)

In the restoration process, we collect as much evidence as possible and analyze and research it to determine a restoration plan. There are a wide range of survey items, but one example is the survey on the wood to be used. For the Sakura Gomon, we decided to use zelkova for the pillars on the first floor based on the texture of the wood grain seen in old photographs and our research of the wood used in *yagura* gates remaining in other castles. However, toward the end of the construction, an unidentified historical document, which is currently under investigation, stated that “the pillars of the Sakura Gomon had deteriorated, so they were covered with zelkova boards.” In other words, the zelkoba grain seen in the old photo may not be that of the pillar, but of the veneer attached to the surface. Thus, it is not uncommon for new historical documents to be discovered or information to be corrected after the fact as research progresses. On the other hand, it is often physically difficult to modify the details of a restored structure. Restoration and research always face this dilemma.
