# Reinforcement by Modern Construction Method

## Safety as Park Facility

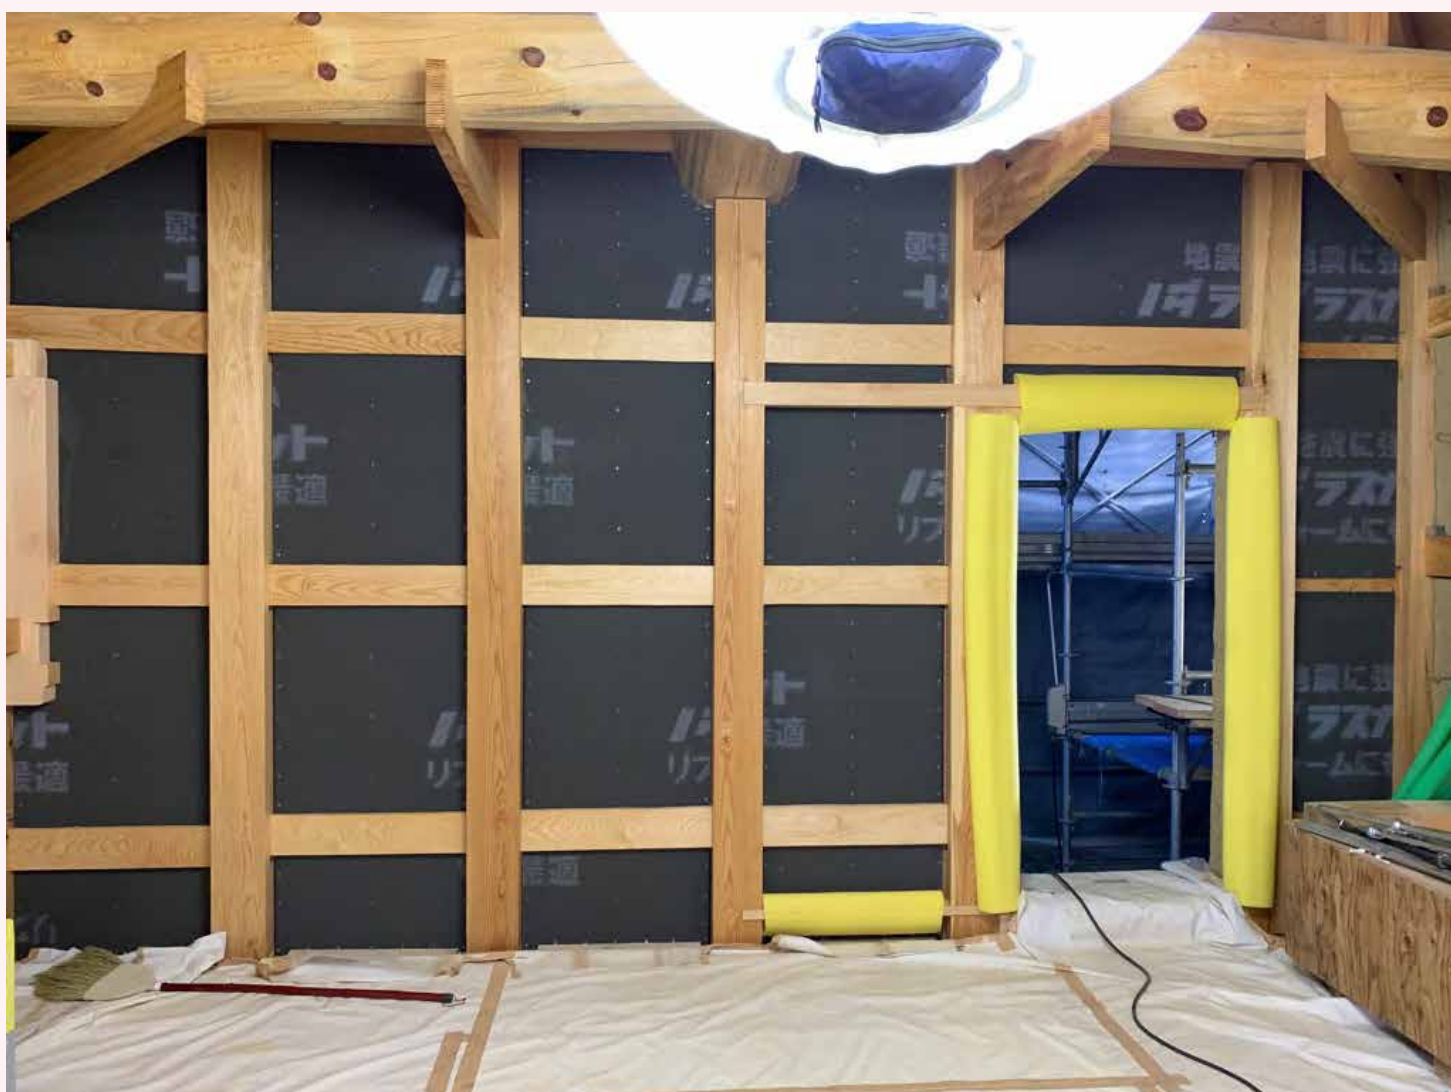
Structural Plywood Installed in the Wall

The restoration of the Sakura Gomon was designed primarily to faithfully implement the rationale for the reconstruction. At the same time, it is a new structure in the park. Although we were exempt from the Building Standard Law for this construction, we have taken the necessary safety measures to ensure that the structure is open to the public and manned from a modern perspective, including earthquake resistance and fire prevention measures. Reinforcement measures were basically taken in places that were hidden when completed except angle braces at the four corners of the chamber are the only visible reinforcement. Other than these, structural plywood and other materials were installed in the wall for reinforcement.
